REPORT ON STRUCTURAL INSPECTION

4th December 2020

Re: Structural Inspection to Sunnyside, Kents Lane, North Weald, CM16 6AX

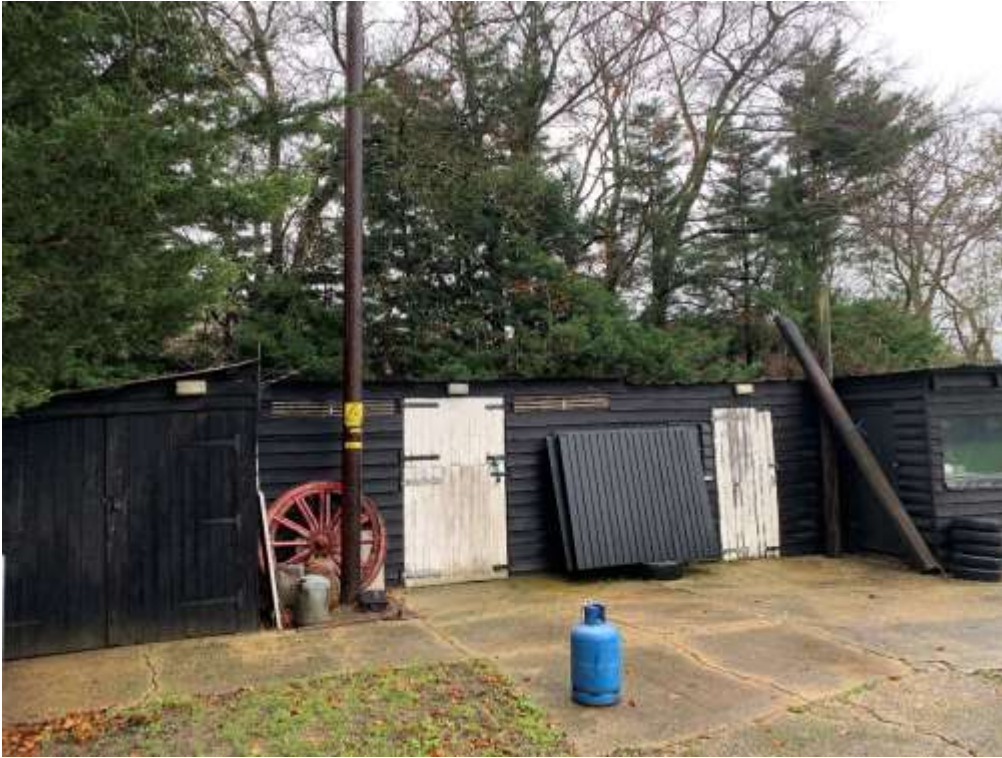
- 2.05 The property is mainly formed of timber weatherboarding to the front elevation fixed to a timber frame wall behind. The rear elevation generally is formed from timber studs with corrugated metal sheeting. Please refer to photograph 1 & 2 in Appendix 1. An area of concrete hardstanding was noted in front of the structure.

Photograph 1 – Building Front Elevation

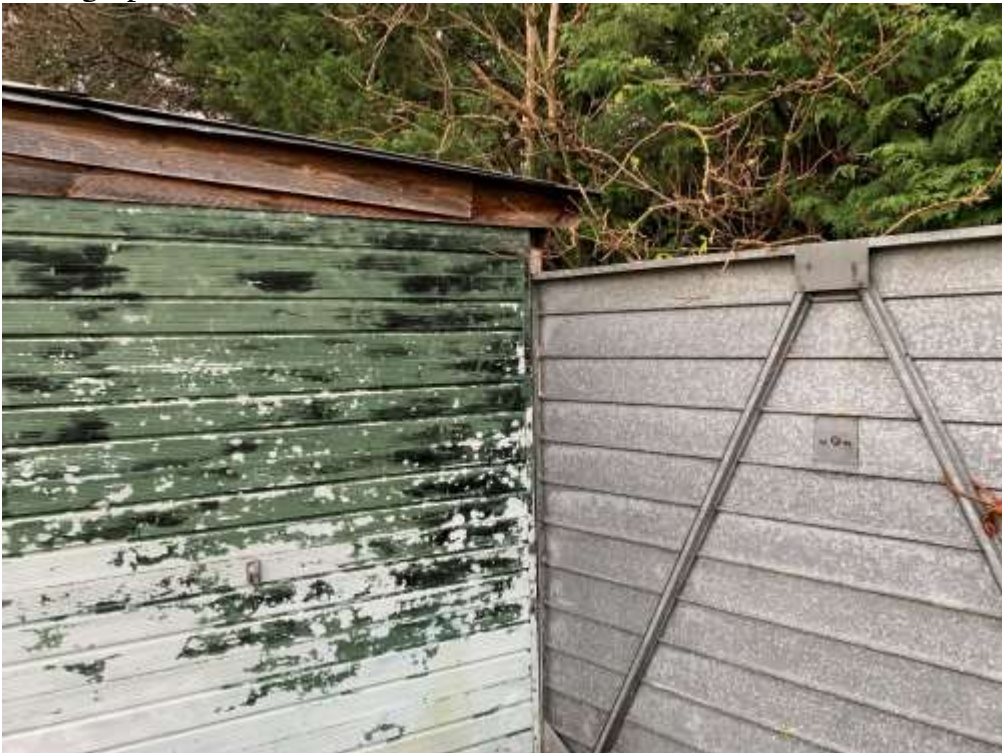
Photograph 2 – Side Elevation

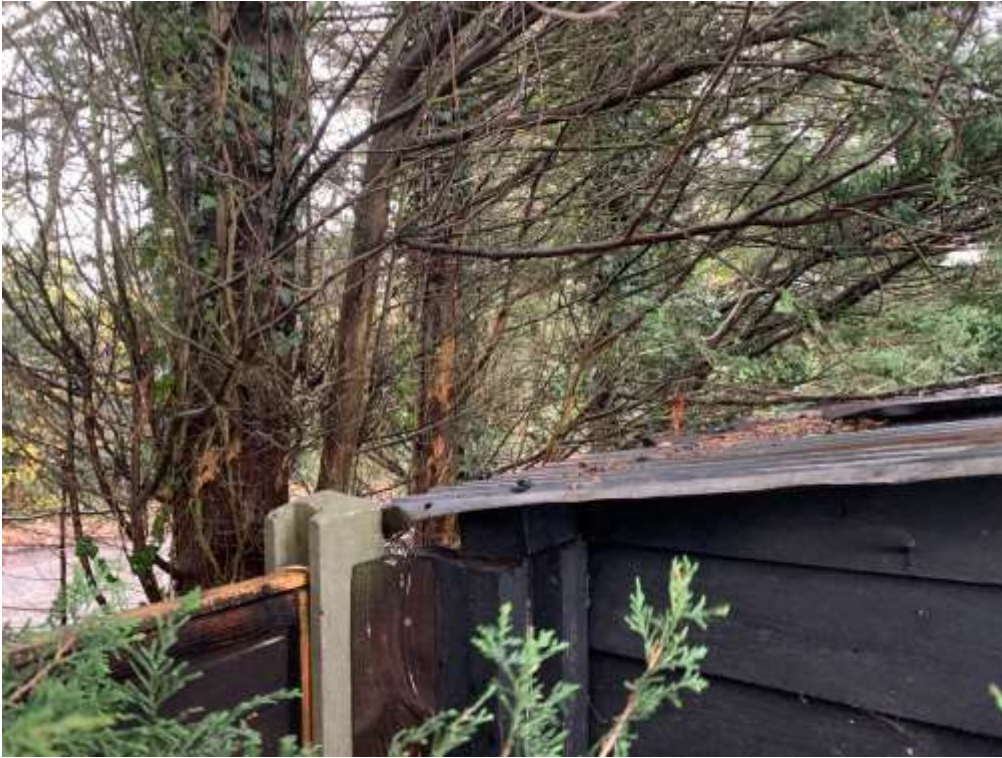
- 2.06 The roof pitches generally from front to back draining off to the rear. Area 1 roof slopes in the opposite direction.
- 2.07 There are various large mature trees along the rear Eastern elevation and northern elevation. Most of the trees appeared to be Cypress Leylandii with possible Maple and Beech in places. Trees were in close proximity to the existing structure and under 1m away in places. Please refer to Photograph 3 in Appendix 3.

Photograph 3 – Trees to North Elevation

- 4.03 We expect from a structure of this type and age that no or very shallow existing foundations are likely to have been used. We also expect from its location that the ground below is very likely to be a high plasticity clay material. Where buildings are founded on a layer of moisture susceptible material, it is prone to heave and desiccation especially when subject to high water demand trees in the vicinity. We believe the ditch may be helping keep roots away from the structure but the trees would still be having influence on the structure. Under current regulations (NHBC chapter 4.2 – Building near trees) foundation depths in this situation are set deep enough to avoid any influence from surrounding trees. We have run some calculations which form Appendix 4 and foundation depths would need to be over 3m deep. This depth is typically too deep for a traditional underpinning solution due to health and safety requirements so we would suggest that a scheme of piled underpinning might be required under the load bearing walls. This could be done by a mini piling rig internally to a suitable depth with a concrete beam formed below the walls.

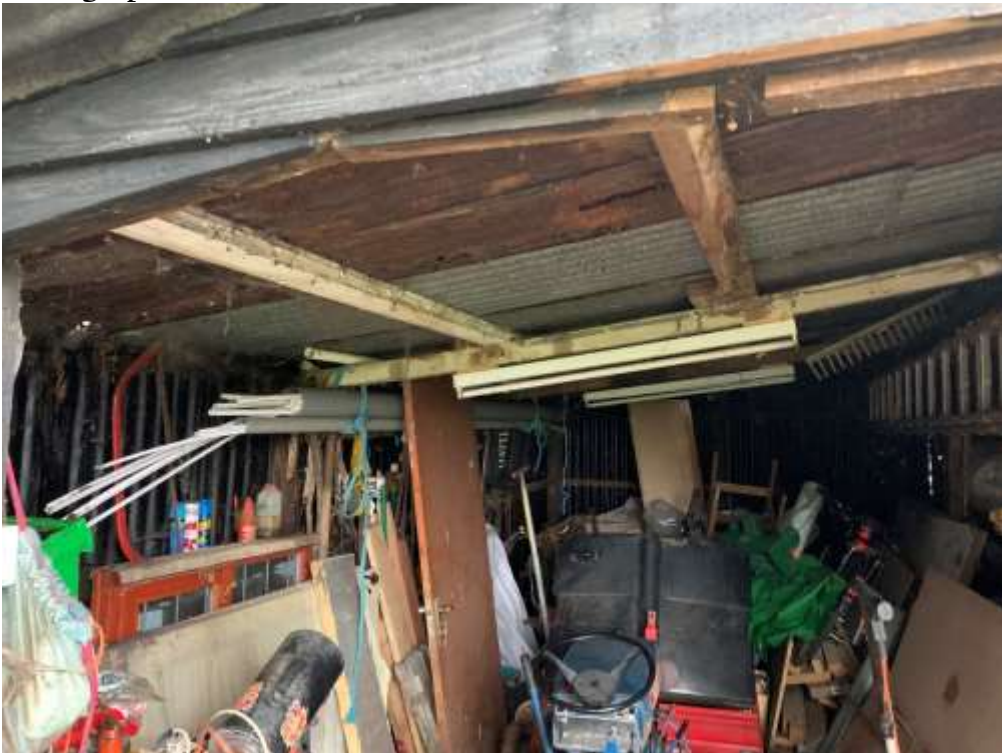
- 3.01 Area 1 - Please refer to Photograph 4 & 5 in Appendix 3. This roof in this area slopes down to the ditch on the north elevation. The roof was formed from small timbers around 100mm deep with corrugated sheeting directly on the top. No guttering was noted. Timbers studs forming the wall were at very large centres with corrugated sheeting fixed to them. There was no concrete floor in this area with just bare ground being used.

Photograph 4 – Area 1 – Internal View

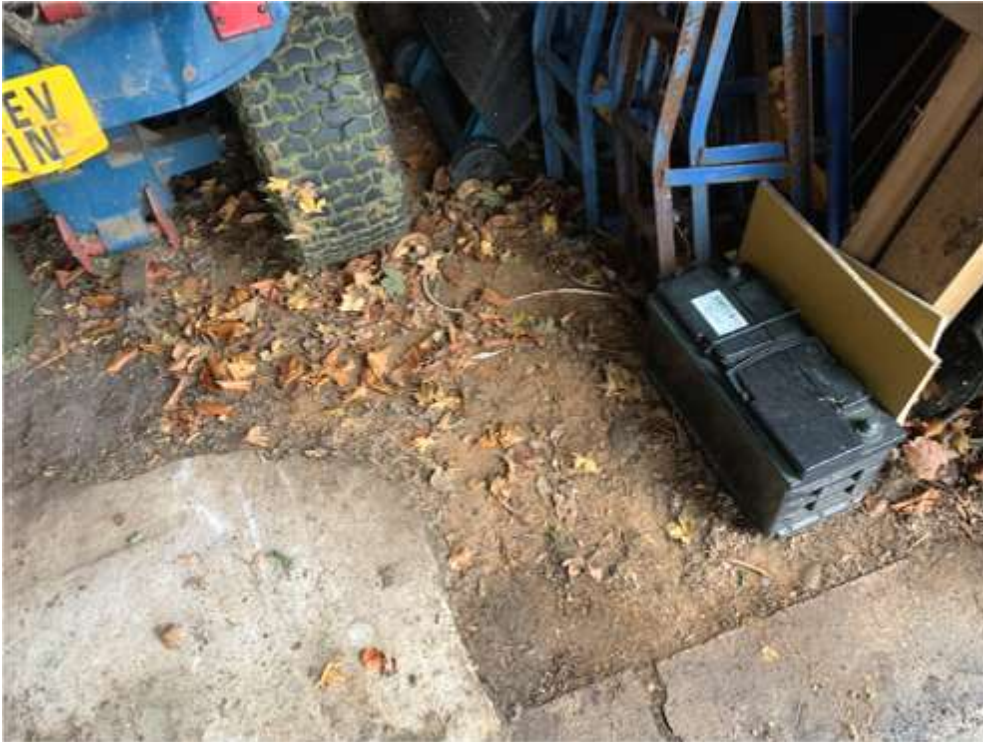
Photograph 5 – Area 1 – Lack of concrete floor

- 4.07 The areas where only the ground is forming the floor would need to be addressed. New concrete floors in these areas could be added. In new areas, these may be

required to be suspended with a void below to stop any possible heave from the tree influence. Insulation to Architects requirements would need to be installed.

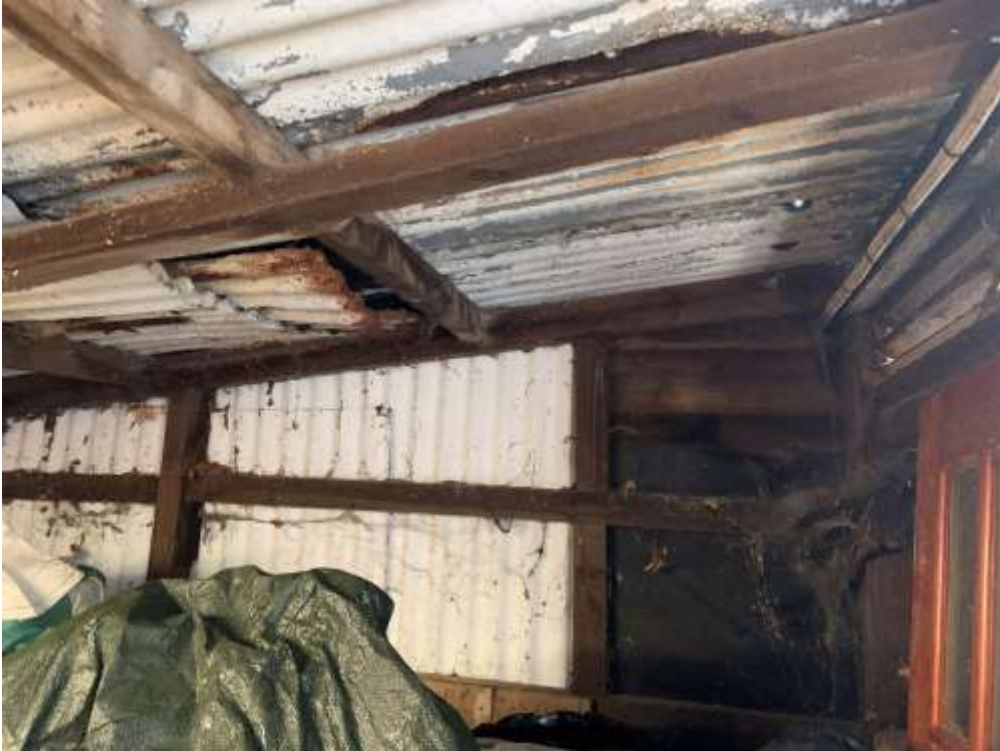
- 3.02 Area 2 - Please refer to Photograph 6 & 7 in Appendix 3. This roof in this area slopes down to the ditch at the rear eastern elevation. The Roof was formed from small timbers around 100mm x 50mm with corrugated sheeting directly on the top. Some of the timbers were turned on their side so only 50mm deep. No guttering was noted. Timbers studs forming the wall were at very large centres with corrugated sheeting fixed to them. There was no concrete floor in this area with just bare ground being used.

Photograph 6 – Area 2 – Internal View

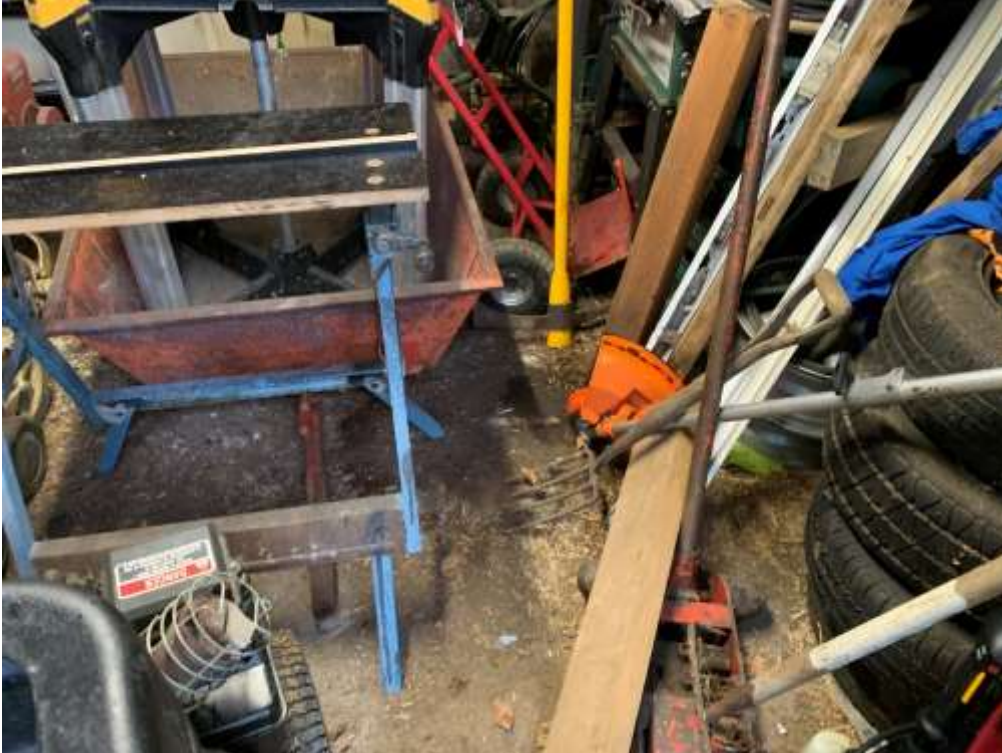
Photograph 7 – Area 2 – Lack of concrete floor

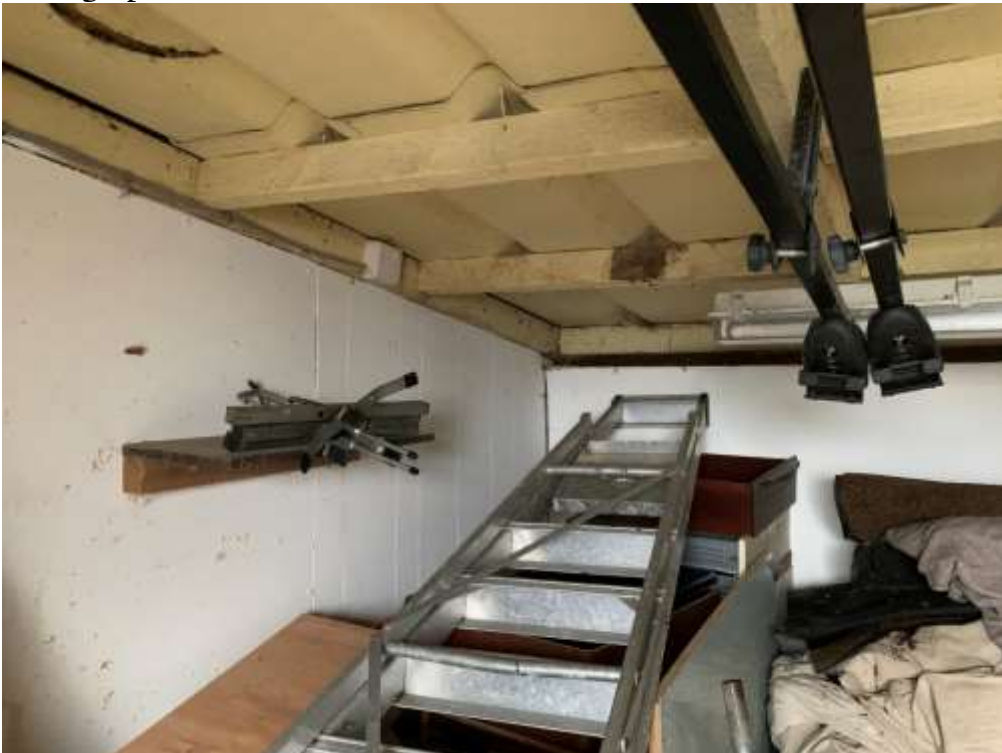
- 3.03 Area 3 - Please refer to Photograph 8 & 9 in Appendix 3. This roof in this area slopes down to the ditch at the rear eastern elevation. The Roof was formed from small timbers around 100mm x 50mm with roofing tiles laid directly on the top. The roof here was different to other areas and should be tested to see if made from Asbestos. Should Asbestos be found then they should be replaced by a specialist company. Timber studs forming the wall were at very large centres. An internal timber finish was present in this area. There was also a concrete floor in this area. Due to storage only parts could be seen but no disrepair was noted to visible areas.

Photograph 8 – Area 3 – Internal View

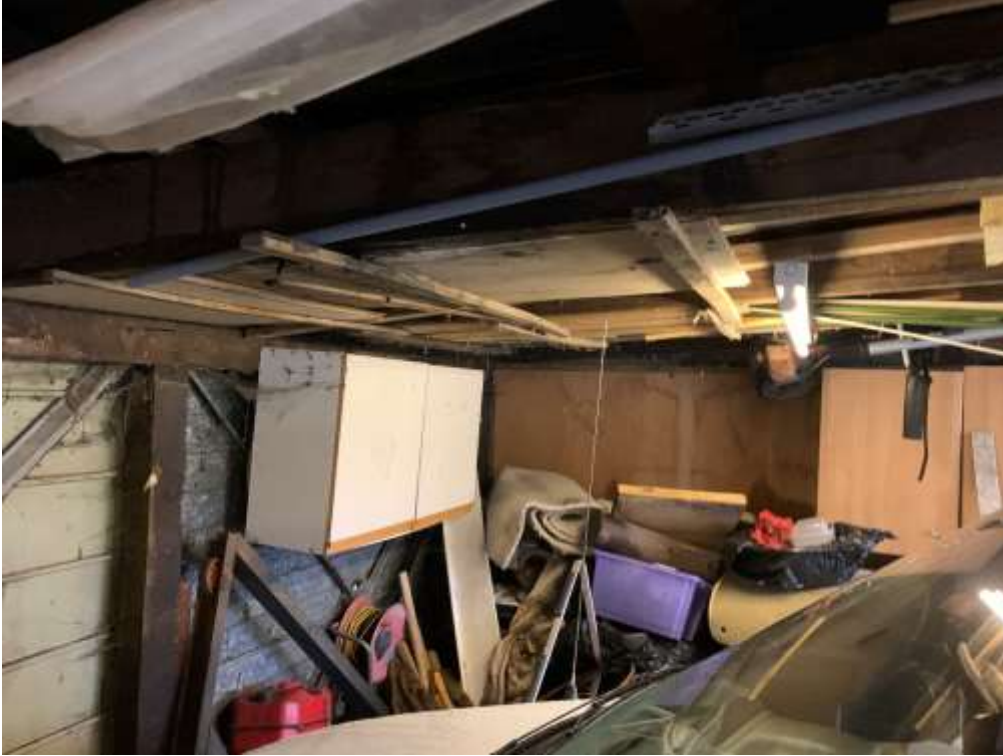
- 3.04 Area 4 - Please refer to Photograph 9 & 10 in Appendix 3. This was the largest of the four different areas. The roof in this area slopes down to the ditch at the rear

eastern elevation. The Roof was formed from small timbers around 100mm x 50mm at 900mm centres with sheeting laid directly on the top. Leaks were noted at the time of our visit. Timber studs forming the wall were at very large centres. An internal timber finish was present in this area. There was also a concrete floor in this area. Due to storage only parts could be seen but no disrepair was noted to visible areas. The floors were notably wet from the leaking roof.

Photograph 9 – Area 4 Internal View

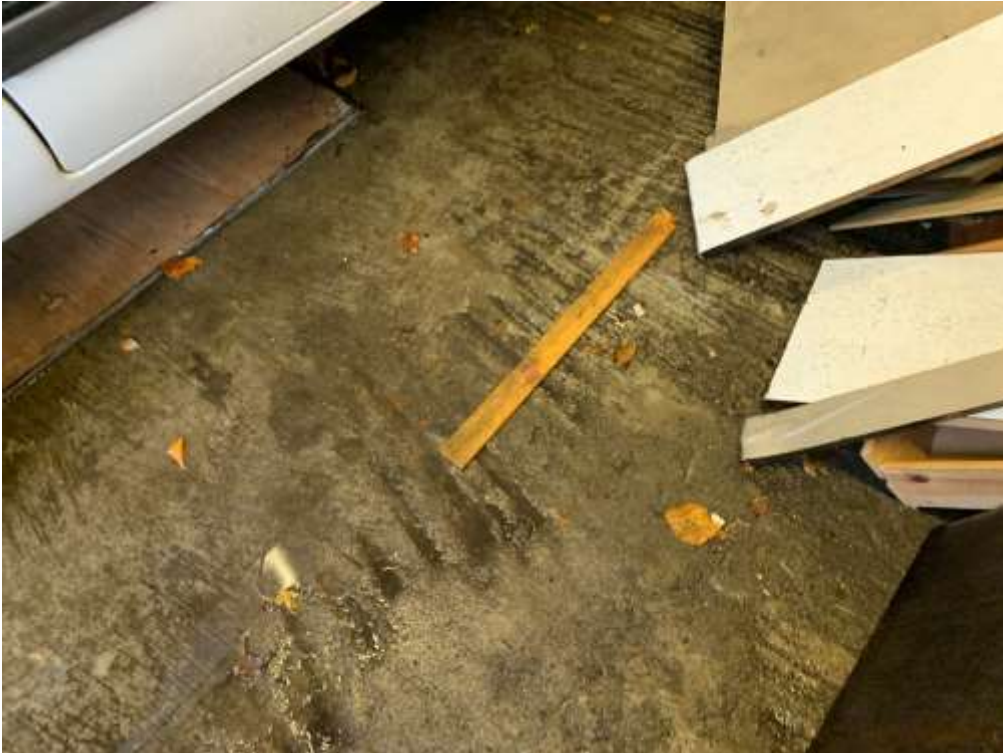
Photograph 10 – Area 4 Concrete Floor
