After reviewing the Preliminary Ecological Appraisal, Preliminary Roost Assessment and Preliminary Ground Level Roost Assessment of 76 Algers Road Report (Document reference no: AR-181018) produced by Kingfisher Ecology Ltd on the 18th October 2018, and undertaking a walk over survey to assess the current ecological conditions on site on the 8th March 2021, I can confirm that the site conditions have not changed.

Table 1: Ecological conditions on the site with supporting images from 2018 and 2021 respectively

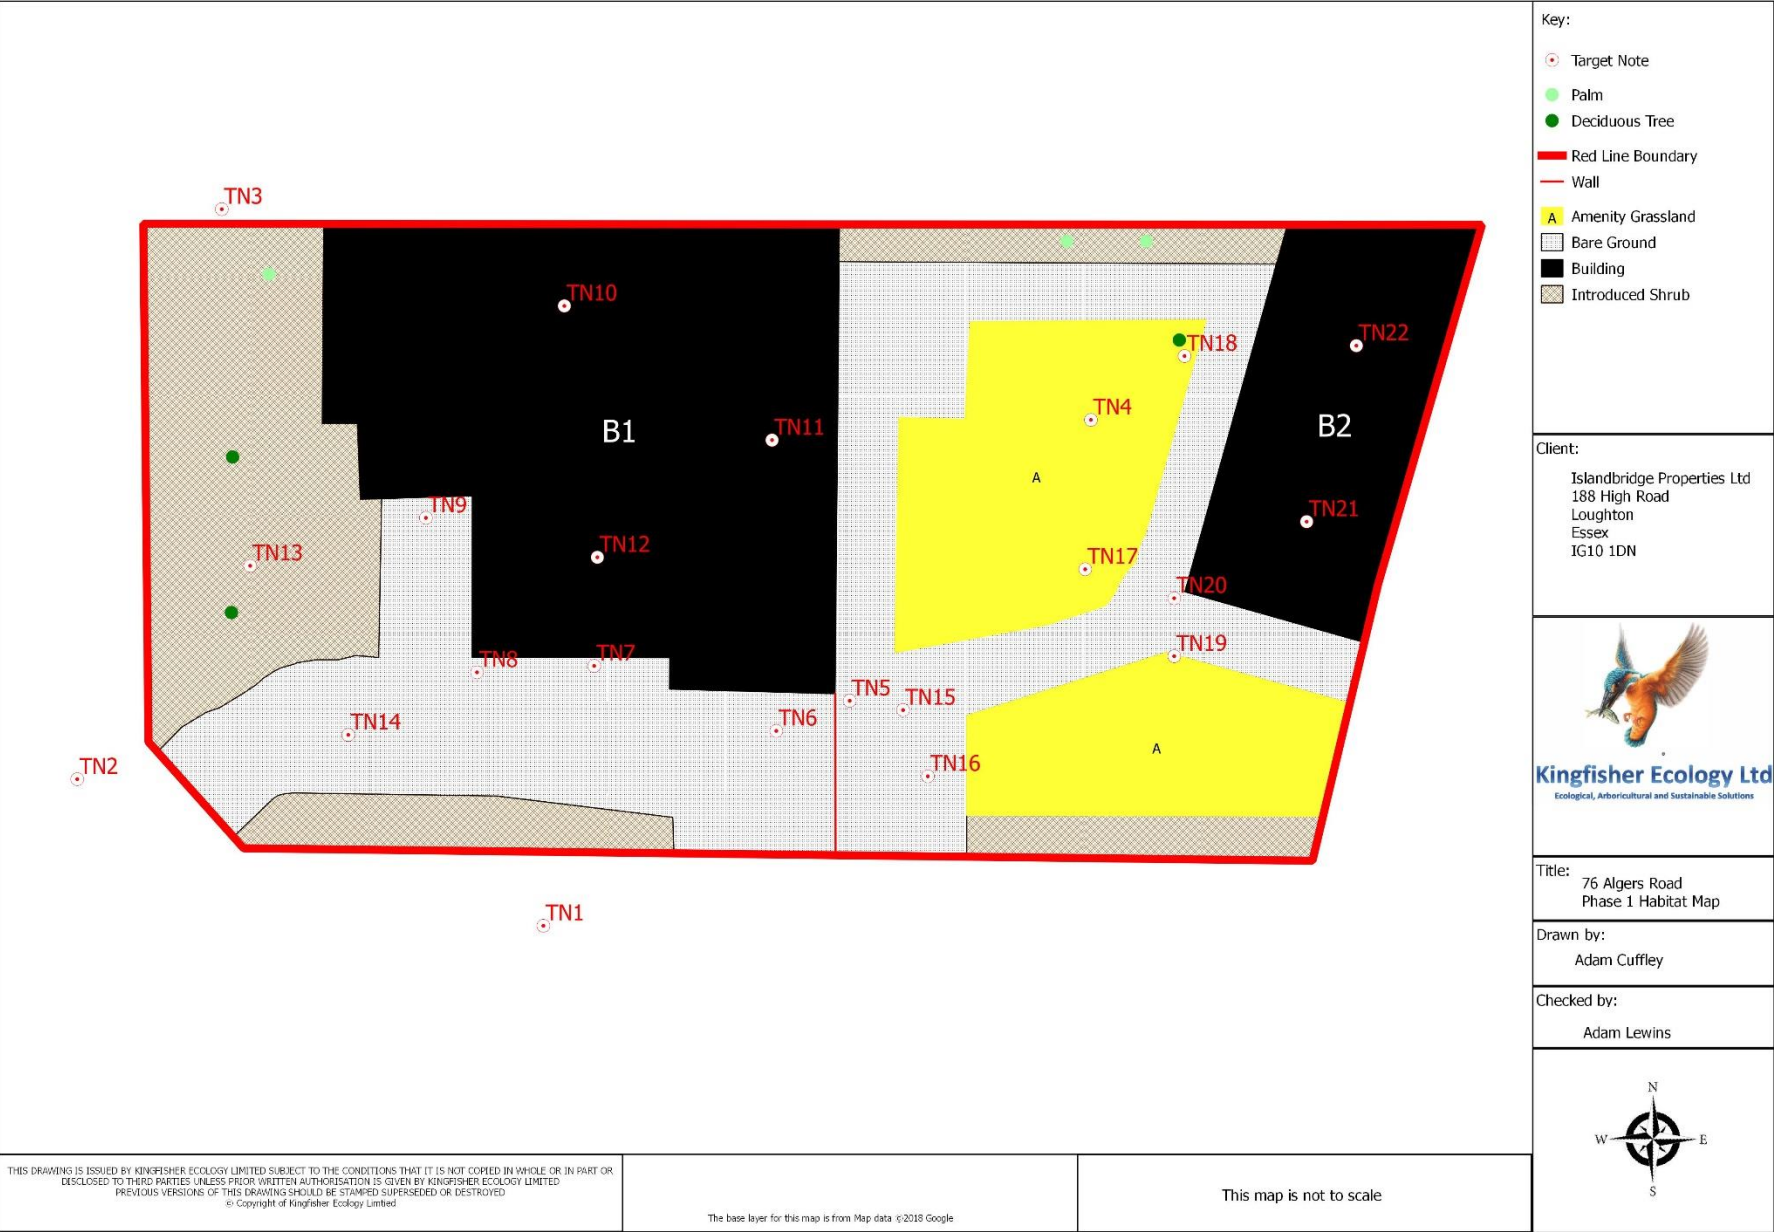
Figure 1: Phase 1 Habitat Map of the site completed in 2018

During the original survey completed in 2018, the site had been left unmanaged and therefore the vegetation had become overgrown, providing suitable habitat for reptiles. The site has remained largely unmanaged, which has allowed further encroachment of vegetation across the site, particularly in the eastern section. The trees on the western boundary have been felled, and the introduced shrub on the west and south boundaries have been removed. The species composition of the amenity grassland across the site has shifted from grass species to pioneer herb species such as colt's-foot (*Tussilago farfara*) and other ruderal species. The habitat provided by the vegetated areas for protected species remains the same. Please refer to the Phase 1 habitat map in Figure 1 below.

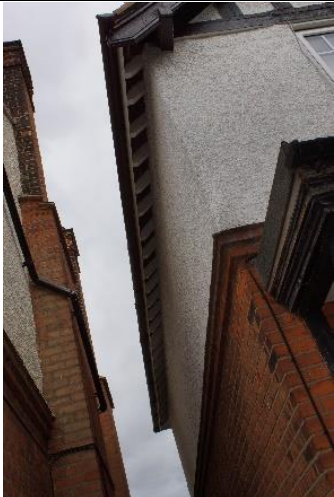
TN3	<p>The images show the eaves of the roof on the north elevation of B1. There are no visible changes to the eaves since the initial survey.</p>

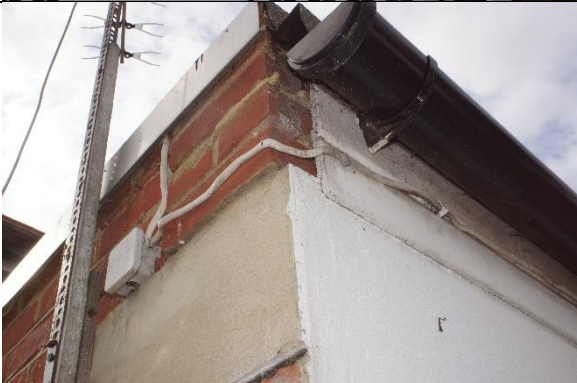
TN4	<p>Images show the north elevation of B1.</p>	 	 
TN5	<p>The images show the loosely fitting roof felt on the north east corner of B1. The gaps provide potential access for roosting bats. The gap has not changed since the first survey.</p>

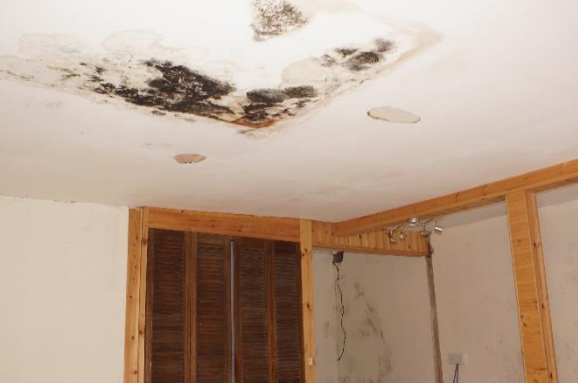
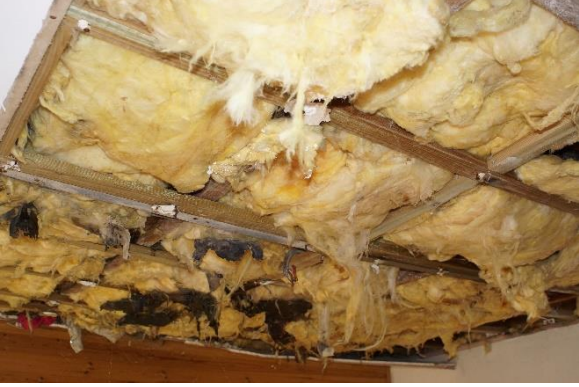
T21	<p>Image 1 shows the internal ceiling of B2. The building has a flat roof with no access to the void. The internal ceiling is in poor condition; however, no gaps were present at the time of survey and no evidence of roosting bats was observed.</p> <p>Image 2 shows the same internal elevation of B2, however the internal ceiling has become further damaged and the insulation is now visible.</p>

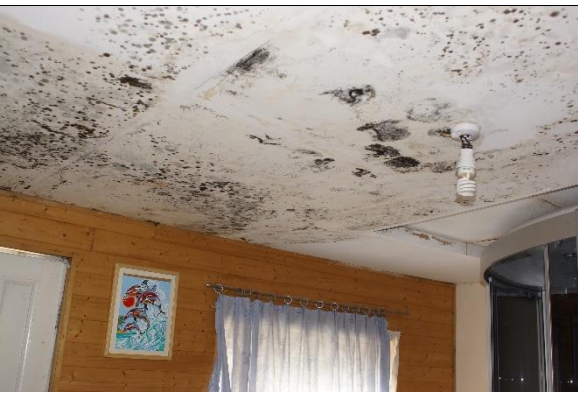
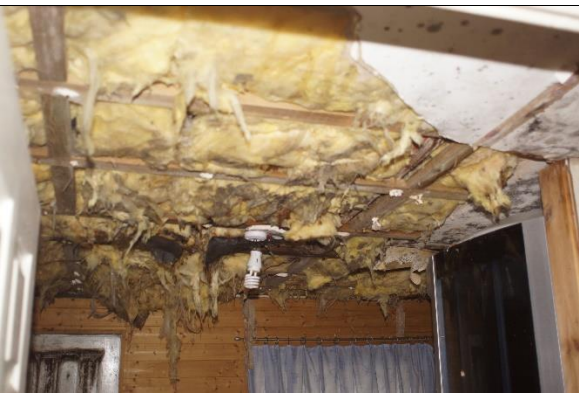
T22	<p>Image 1 shows the internal ceiling of B2. The building has a flat roof with no access to the void. The internal ceiling is in poor condition, however, no gaps were present at the time of survey and no evidence of roosting bats was observed.</p> <p>Image 2 shows the same internal elevation of B2, however the internal ceiling has become further damaged and the insulation is now visible.</p>

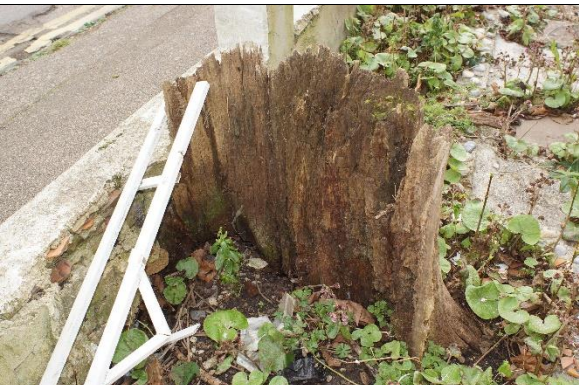
N/A	<p>The adjacent image shows deadwood present on the southern boundary of the site which provides habitat for stag beetles.</p>	<p>N/A</p>

- An ecological watching brief must be present for the disturbance of the deadwood on site due to potential for stag beetles to be present.
- Enhancements to the vegetation of the site after development could be made that will benefit local wildlife. A considered planting strategy to benefit specific nocturnal or diurnal species should be incorporated into the landscape design.
