ARBORICULTURAL IMPACT ASSESSMENT

4 ELY PLACE,

ARBORICULTURAL SOLUTIONS LLP

ORIGINAL – JULY 2021.

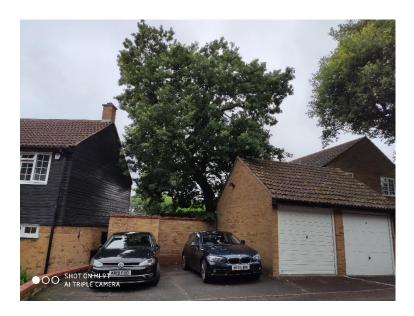
5.1.3. Trees 1 and 2 are mature Oaks adjacent to the house. Tree 1 is located within the rear garden of 3 Ely Place and tree 2 at the front of 4 Ely Place. The trees are generally in good condition and of normal vigour and predate the construction of the houses in Ely Place. Both trees are managed by crown reduction and there is a current approved consent to reduce the overhanging branches of tree 1 by up to 2m metres and reduce the lateral branches of tree 2 by 2 metres.

Photograph 3 showing tree 1 within the rear garden of 3 Ely Place.

6.1.4. There is an existing TPO consent to cut back the overhanging branches of tree 1 by up to 2 metres. This will remove the overhanging branches and clear the aerial space above the existing extension and so allow the construction of the first-floor extension.

Tree No.	Recommended Works
T1 & T2	T1 – Crown reduce overhanging lateral branches by up to
(Oak)	2 metres.
	T2 - Crown reduce lateral branches by up to 2 metres.

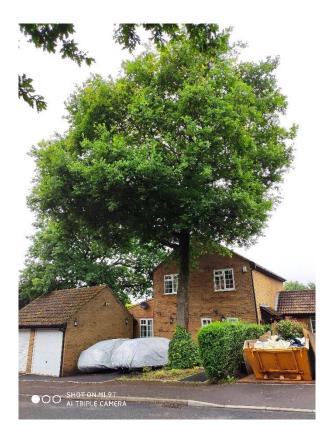
Photograph 4 showing tree 2 at the front of 4 Ely Place.

8.5.1. The supporting posts for the canopy are within the RPA of tree 2, the excavations for supporting posts/foundations should be excavated by hand to ensure no roots are present. If significant roots >than 25mm diameter are found it may be possible to cut them under advice from a suitably qualified arboricultural professional. If the roots have to remain, the design should be suitably flexible to allow repositioning of any foundation structure. Any design involving concrete must utilise an impermeable membrane in the excavation to prevent concrete leachates contacting roots.
