# Arboricultural Appraisal Report

Impact Assessment & Method Statement to Inform Development

Garages at  
Lower Alderton Hall Lane  
Loughton,  
Essex  
IG10 3HA

CLIENT:	ECD Architects
MWA REF:	DEV181105-348Rev01
MWA CONSULTANT:	Mark Bisley <small>BSc Hons</small>
REPORT DATE:	10/01/2019

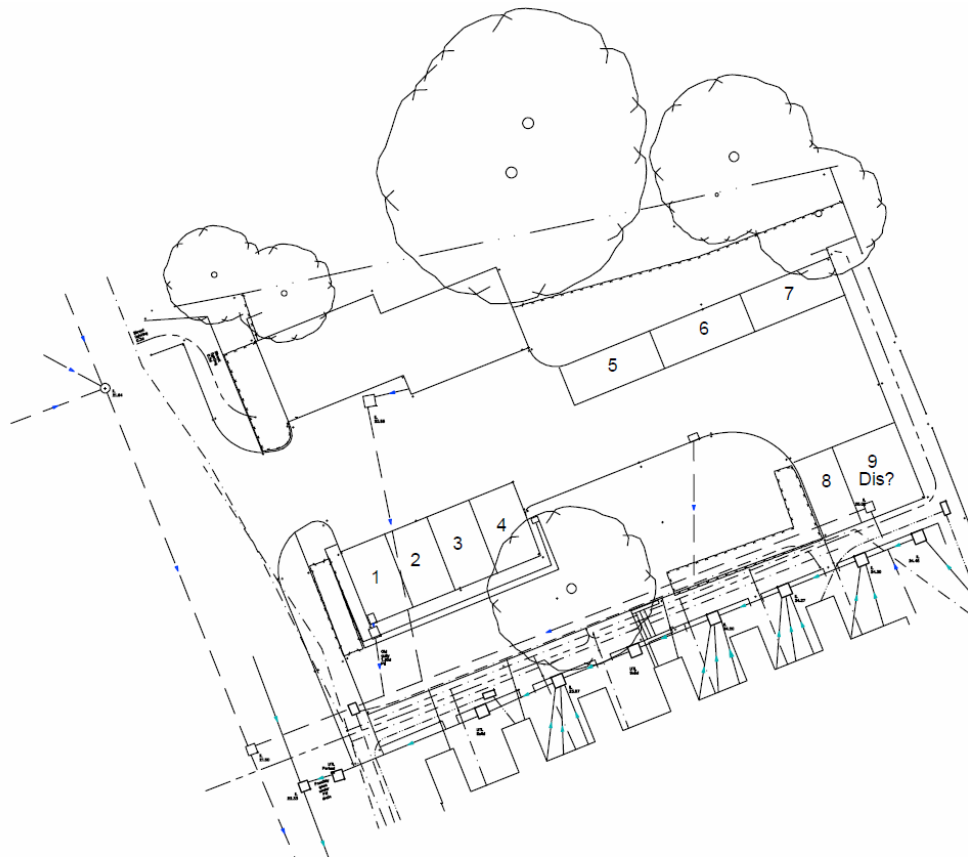
**Figure 1: Existing Situation**

- 6.2 A single ornamental tree is located on the southern side of the site and hedges towards the west and eastern part of the southern boundary. The majority of the tree cover is located either just inside or beyond the northern boundary fence.

- 6.3 T1 is a previously reduced tree that is likely to need additional works in the future, but is currently of moderate quality and value. The hedges are low level features that soften the space but are of no particular arboricultural value.

- 6.4 Vegetation along the northern side of the site is generally of low quality but has significant collective value as a landscape feature. TG1 along the site side of the boundary fence is generally self-seeded and would need to be removed to prevent damage to the fence in the future. TG2 is likely to be subject to periodic works by the railways and past maintenance has resulted in the low quality of the specimens as individuals.

- 6.5 T2 is an established ornamental tree that is located very close to a light column. This has led to the tree being cut back to the south in the past and suppression from the north further reduces the quality of the tree.
