BS5837 Arboricultural Report,

Arboricultural Impact Assessment

| OUR REFERENCE | AC.2021.526 |
| SITE | Land south of Chigwell Cemetery, Chigwell, Essex, IG7 5PS |

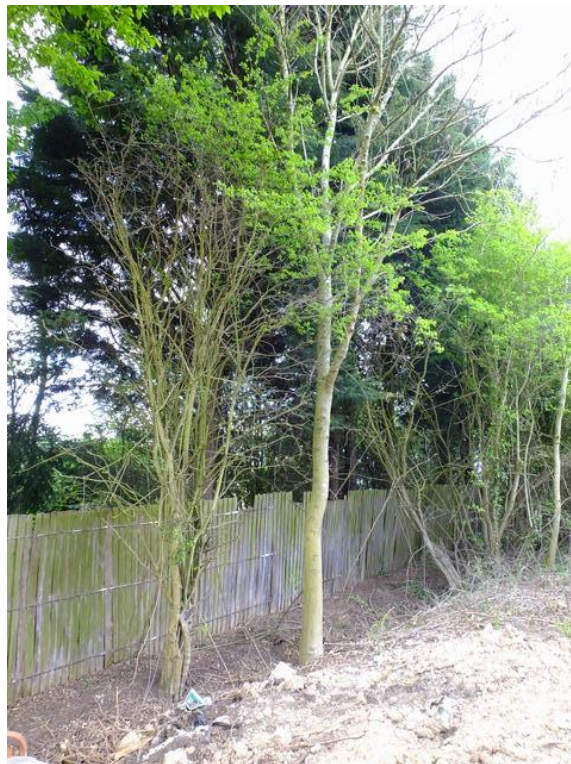
Image 6 T73 an ash tree exhibiting signs of ash dieback

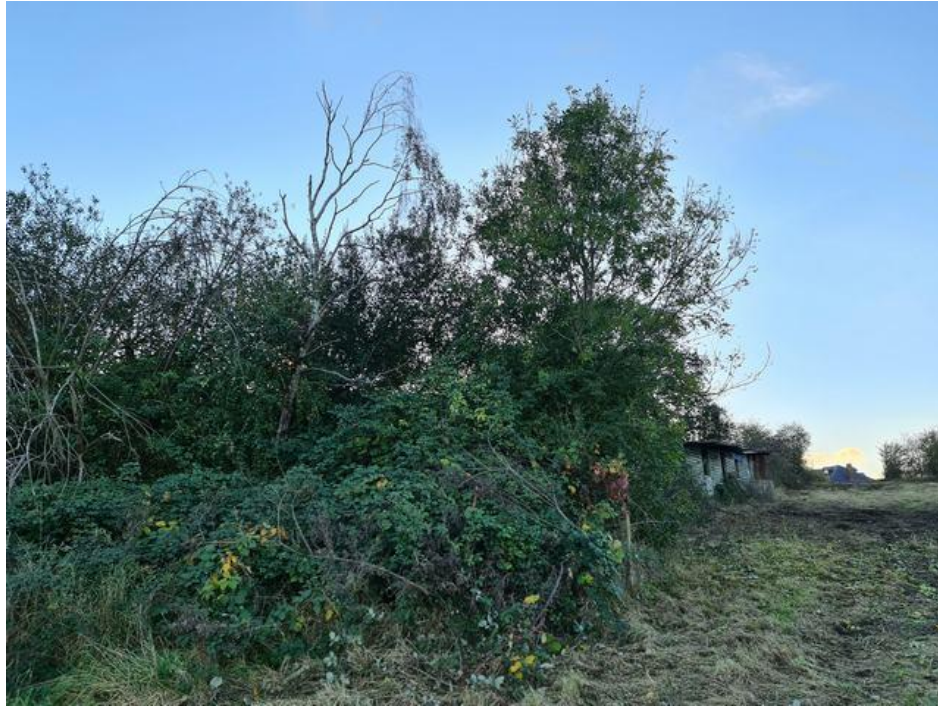
Image 13 Scrub and brambles around T17 to T21.

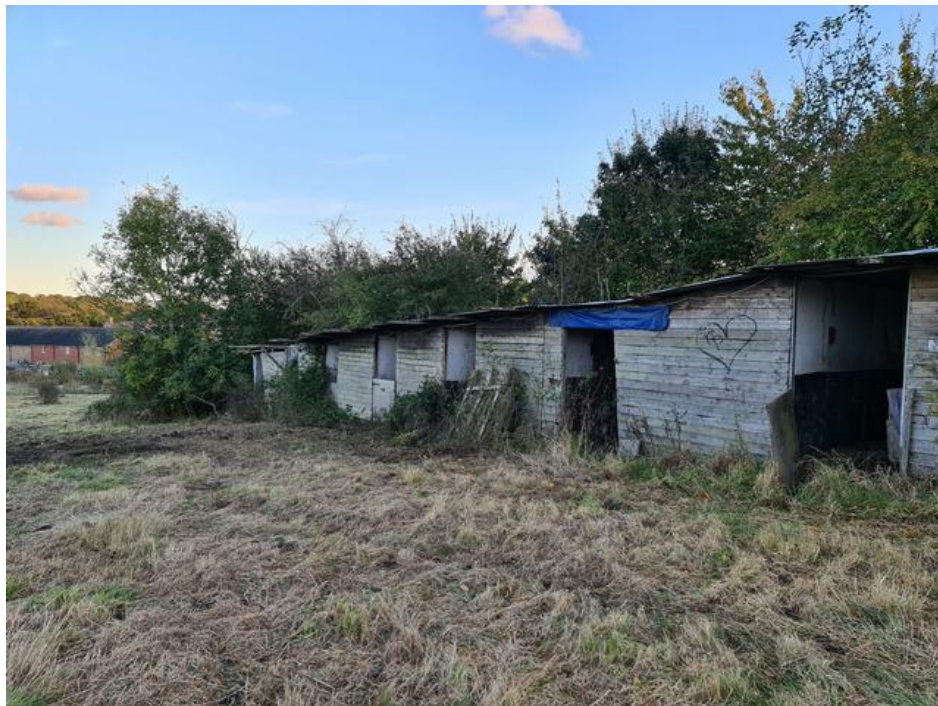
Image 14 Scrub and brambles around T17 to T21.
