Arboricultural Report and Arboricultural Implications Assessment REV D

Site – 4A Kendal Ave, Epping, Essex,

Client – Clear Architects

Date of survey - 29-03-17

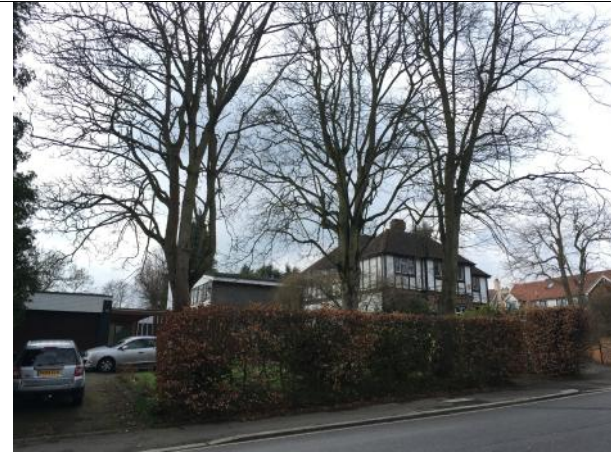
Trees T5 left to T7 right viewed from the highway

T7	<i>Lime</i>	150	6.9	<p>Crown Access for the build will be required under the crown.</p> <p>Roots The new building and basement are outside the root area.</p>	<p>Crown The crown has a good ground clearance for access.</p> <p>Roots Additional ground protection will be laid where the new drive will go until</p>

<p>The existing slope will be retained to protect the roots.</p> <p>A small section of the extended drive encroaches into the edge of the root area.</p>	<p>the drive is installed.</p> <p>The new surfacing will be a no dig construction. It will have a geogrid sub base such as cellweb or similar. The surface treatment will be porous. Edges will be treated timber. See appendix 4.</p> <p>The area at the entrance will require localised excavation to approximately 150-200mm to allow for the new no-dig drive to match existing highway levels. This will be carried out by hand with arboricultural supervision. Any roots over 25mm in diameter will be retained and protected under the new area of drive. Greater detail of the method will be provided in an arboricultural method statement.</p> <p>Any works to service runs within the root area will need to be hand dug, any roots over 25mm in diameter retained and protected in line with BS58387:2012.</p>

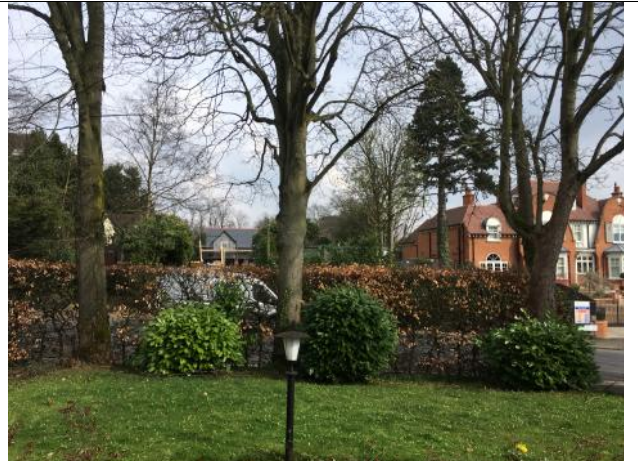
Trees T5 right to T7 left viewed from the garden.

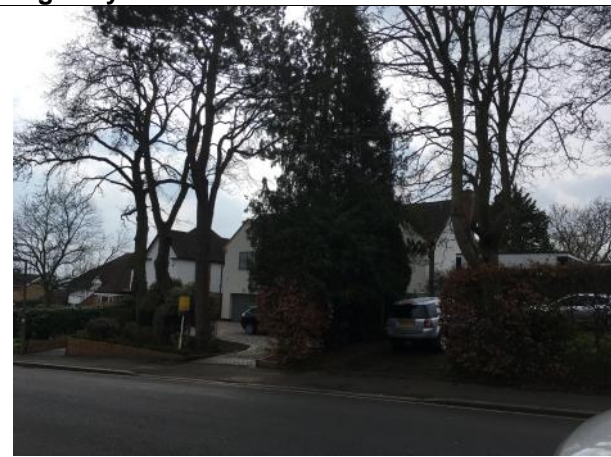
T4	<i>Lawson cypress</i> <i>Chaemacyparis</i> <i>lawsoniana</i>	9	19	N 0 S 1 E 0 W 1	1	Y	Poor	Poor	Na	>10	U
The tree is located on the boundary, ownership is not clear. A high water demand species under NHBC guidance.

Trees T1 to T4 along the boundary in centre of picture

Tree no.		RPA m/sq	Radi of RPA (M)	Tree implications assessment	Mitigation
T1	<i>Lawson cypress</i>	14	2.1	Remove to facilitate the development	
T2	<i>Lawson cypress</i>	85	5.2	Remove to facilitate the development	
T3	<i>Lawson cypress</i>	64	4.5	Remove to facilitate the development	
T4	<i>Lawson cypress</i>	U	U	Remove due to condition	
T5	<i>Sycamore</i>	150	6.9	<p>Crown Access for the build will be required under the crown.</p> <p>Roots The new building is outside the root area.</p> <p>The existing slope will be retained to protect the roots.</p>	<p>Crown The crown has a good ground clearance for access.</p> <p>Protect the trunk for the duration of the build with tree protection fencing in line with BS5837:2012, appendix 2 of this report and drawing CA/4AKA/01</p> <p>Roots The new surfacing will be a no dig construction. It will have a geogrid sub base such as cellweb or similar. The surface treatment will be porous. Edges will be</p>

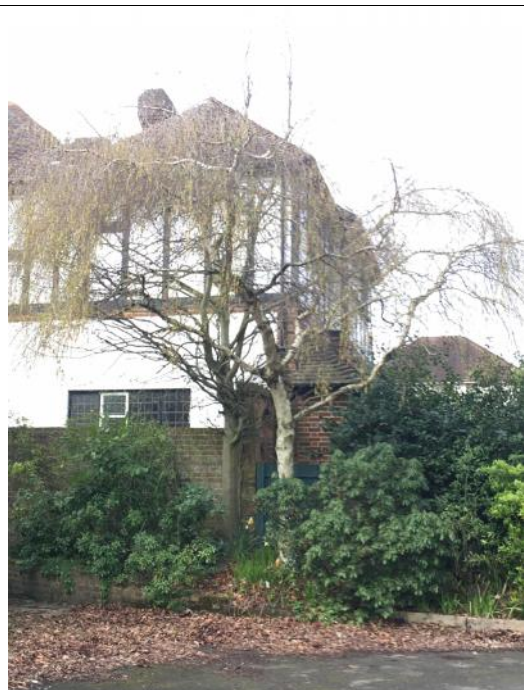
The tree is protected by a tree preservation order. Located on the front of the site, visible in the wider landscape.											
T8	<i>Weeping Silver birch</i> <i>Betula youngii</i>	4	22	N 3.5 S 3.2 E 2.5 W 4.5	2.2 First main limb at 2m high on east side.	Ma	Fair	Fair	Na	10-20	C
A small tree with limited value in the wider landscape.

Trees T8 and T9 viewed from within the site

T8	<i>Weeping birch</i>	23	2.7	Remove to allow access for the build	A small tree with limited value in the wider landscape. Replacement tree to be planted in the rear garden.
T9	<i>Hornbeam</i>	18	2.4	Remove to allow access for the build	The tree is a large species that would be too close to the neighbouring house in time. Replacement tree to be planted in the rear garden.
T10	<i>Lawson cypress</i>	110	5.9	Distant enough from the proposals not to be affected.	Protect the tree for the duration of the build with tree protection fencing in line with BS5837:2012, appendix 2 of this report and drawing CA/4AKA/01
T11	<i>Lime</i>	72	4.8	Distant enough from the proposals not to be affected.	Protect the tree for the duration of the build with tree protection fencing in line with BS5837:2012, appendix 2 of this report and drawing CA/4AKA/01

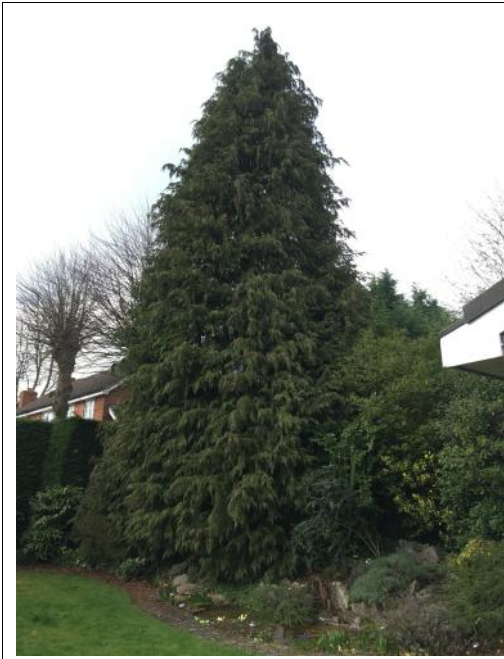
T10 in rear garden

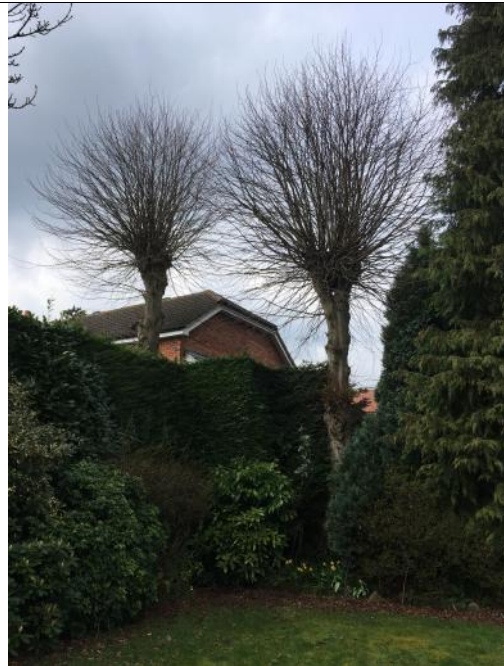
T11 pollarded lime

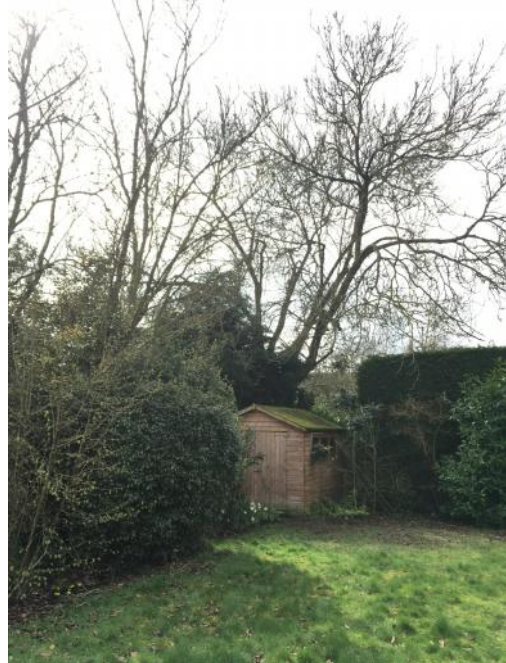
T12 ash in centre with T12 and T13 cherry to the left.

T12	<i>Ash</i>	113	6.0	Distant enough from the proposals not to be affected.	Protect the tree for the duration of the build with tree protection fencing in line with BS5837:2012, appendix 2 of this report and drawing CA/4AKA/01
T13	<i>Cherry</i>	27	3.0	Distant enough from the proposals not to be affected.	Protect the tree for the duration of the build with tree protection fencing in line with BS5837:2012, appendix 2 of this report and drawing CA/4AKA/01
T14	<i>Cherry</i>	27	3.0	Distant enough from the proposals not to be affected.	Protect the tree for the duration of the build with tree protection fencing in line with BS5837:2012, appendix 2 of this report and drawing CA/4AKA/01
T15	<i>Lawson cypress</i>	40	3.5	Distant enough from the proposals not to be affected.	Protect the root area within the site with additional ground protection for the duration of the build.
