**LOWER ALDERTON HALL LANE,
LOUGHTON, IG10 3HA
Phase 1 Contaminated Land Assessment**

Client: Epping Forest District Council

Reference: CB/CC/P18-1619/01

Date: December 2018

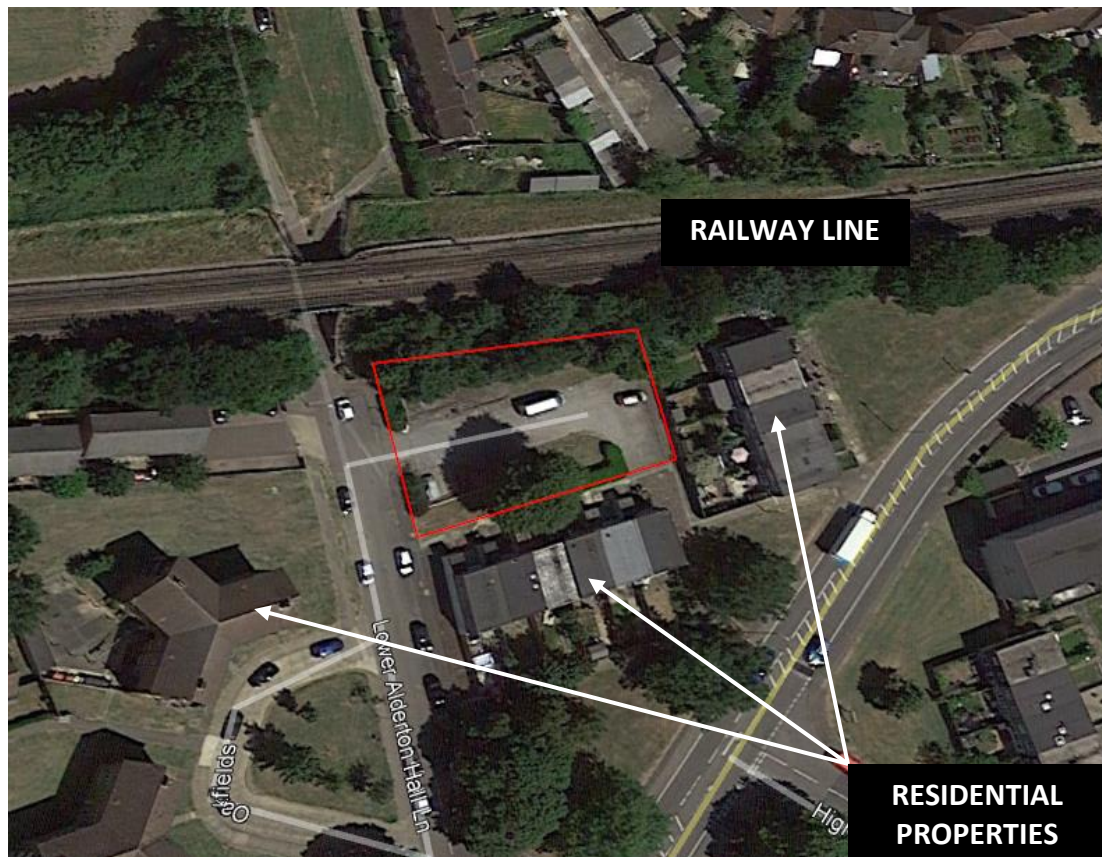
Figure 3.3: Surrounding Land Use Plan

- 3.10 The Site is located within a residential area, bounded to the east and south directly by residential properties (Photos 2 and 5, Appendix B), to the west by Lower Alderton Hall Lane with residential properties beyond (Photo 6, Appendix B) and to the north by the embankment for the railway line (Photo 1, Appendix B).
- 3.11 An overview of the surrounding area is provided in Figure 3.3 overleaf.

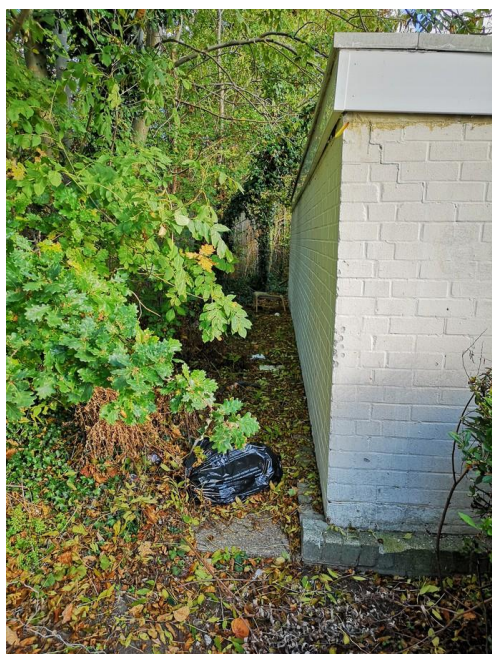
- 3.6 To the rear of the garages and along the northern boundary to the Site is a grassed verge area with trees beyond bordering the Site (see Photos 3, 4 and 5). To the rear of the garage units, there is some evidence of fly-tipping in the form of rubbish bags (see Photo 3, Appendix B). Along the southern boundary there is another grassed verge area (see Photo 6, Appendix B).
- 3.7 The layout of the Site is illustrated in Figure 3.2 below.

Photo 3: Fly tipped waste and foliage behind the garages along the northern site boundary (looking east)

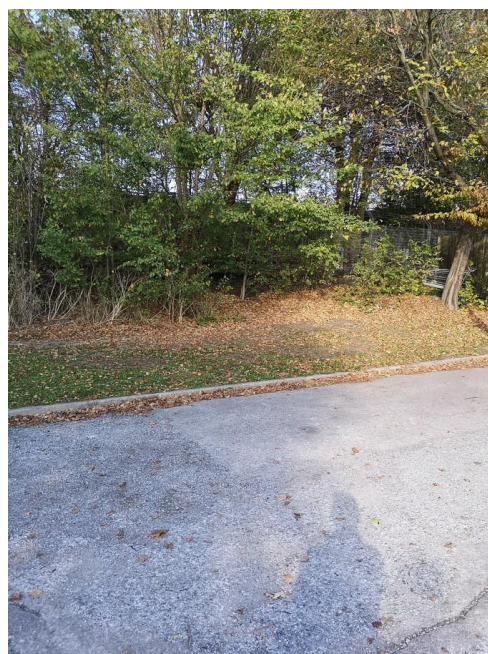
Photo 4: The soft landscaped area occupying the northwest area of the Site (looking north)
