**PROPOSED SCOPE OF WORKS**  
**for a**  
**PHASE 2 ENVIRONMENTAL INVESTIGATION**  
**at**  
**LAND AT POTASH ROAD, MATCHING GREEN, ESSEX,**  
**CM17 0RN**  
**for**  
**RCT CONSTRUCTION LTD**

**Project No 0984**  
**Report ref: 0984-P2E-1-A-Scope**  
**Issued: 29 August 2019**  
**Revision: A**

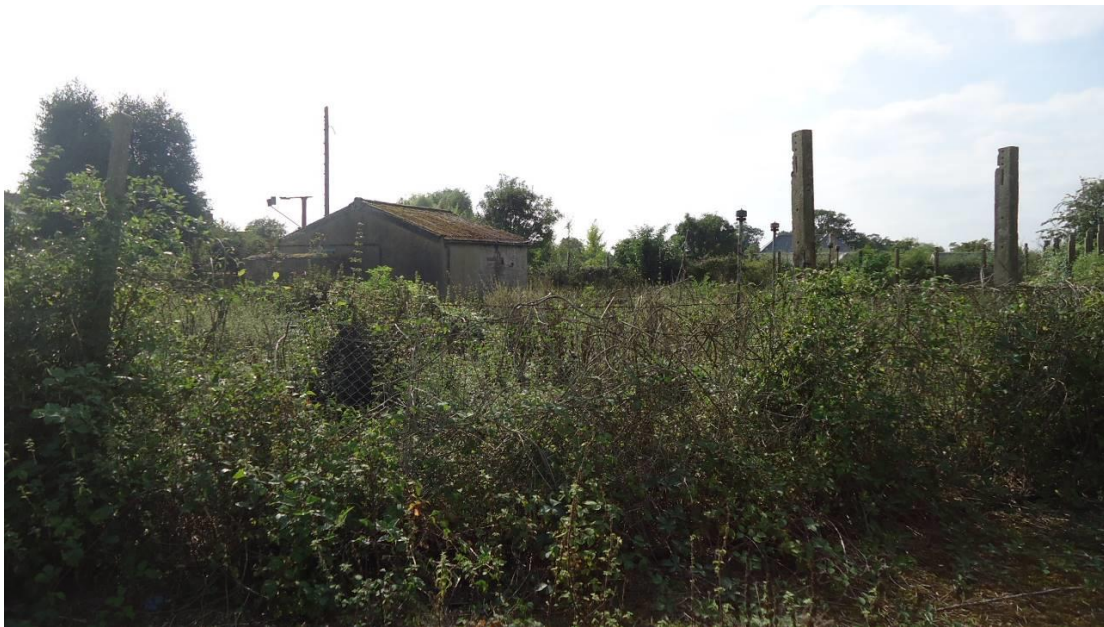
The perimeter of the site is covered by concrete paving which has been poured in bays and provides a vehicle access route. The concrete paving has some surface weathering and cracking but generally appears to be in sound condition. The central part of the site is enclosed by a dilapidated concrete post and chain link fence with a steel framed personnel gate. Drawings provided by the client show that the central part of the site contains six underground storage tanks. The tanks cannot be seen on the site but the tank access covers and valve assemblies are clearly visible along with other ancillary equipment. The central area has stoned surfacing laid on a plastic membrane and is overgrown with brambles and other vegetation. Within the central area is a single storey building constructed in rendered masonry under a corrugated concrete panel roof. The building has a concrete floor which appears to be in good condition and is currently being used to store mainly timber and corrugated steel sheeting. The building contains redundant pipework, electrical equipment and what appears to be a pumping mechanism. There is also an empty steel drum container, two empty plastic water butts and a part filled five gallon plastic container labelled flammable liquid.

Photograph 1: View looking south west across site

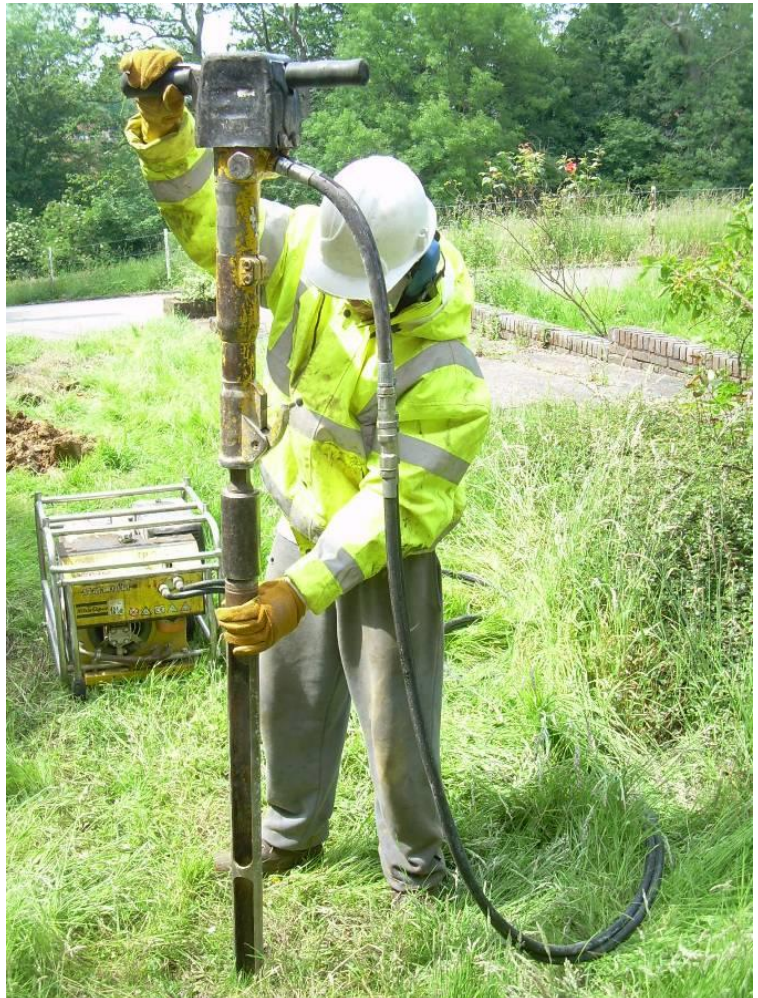
- The drive-in-sampler comprises a series of 1 metre and 2 metre long 80mm to 35mm diameter tubes that are driven into the ground using a mini-hydraulic breaker. The tubes are subsequently jacked out of the ground and side windows enable the tubes to be cleaned and small disturbed samples to be taken. During site operations there will be a certain amount of noise from the hydraulic power pack and breaker unit as the sample tubes are driven into the ground.

Any monitoring installations will comprise 19mm diameter HDPE slotted and plain casing as necessary wrapped in a geotextile sock if necessary to prevent silting up and finished at ground surface with a lockable stopcock cover concreted in flush with the existing ground surface.
