Phase I Geo-Environmental Desk Study

4a Albert Road
Buckhurst Hill
IG9 6EH

EPS Project Reference:	UK20.5225
Date Issued:	15 th January 2021
Report Status:	Issue 1

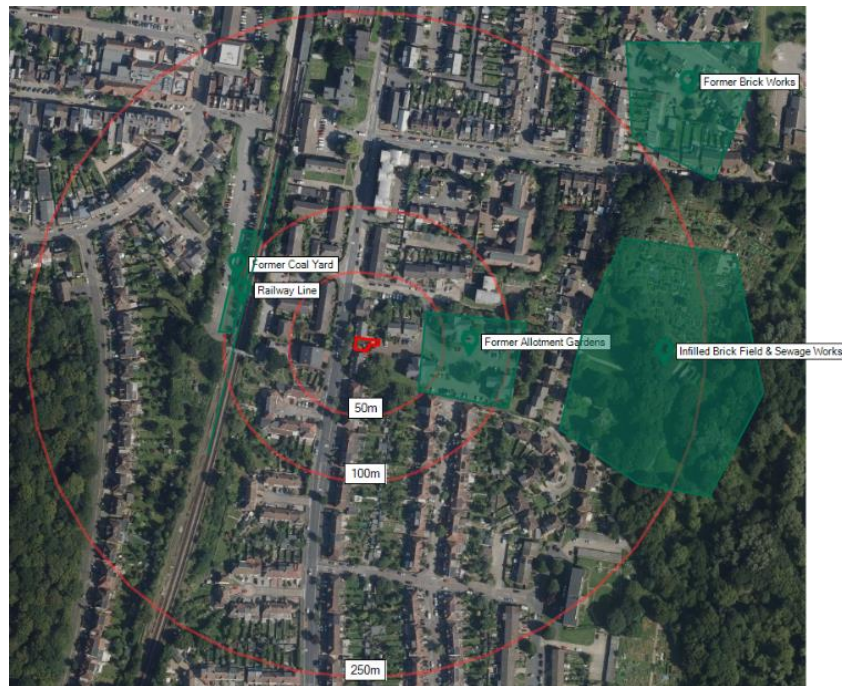
- Mapping from the late 1800s shows that a house appears to encroach on the western edge of the site, however this seems to have been demolished by the 1990s when the current layout is shown. No other site use is recorded.

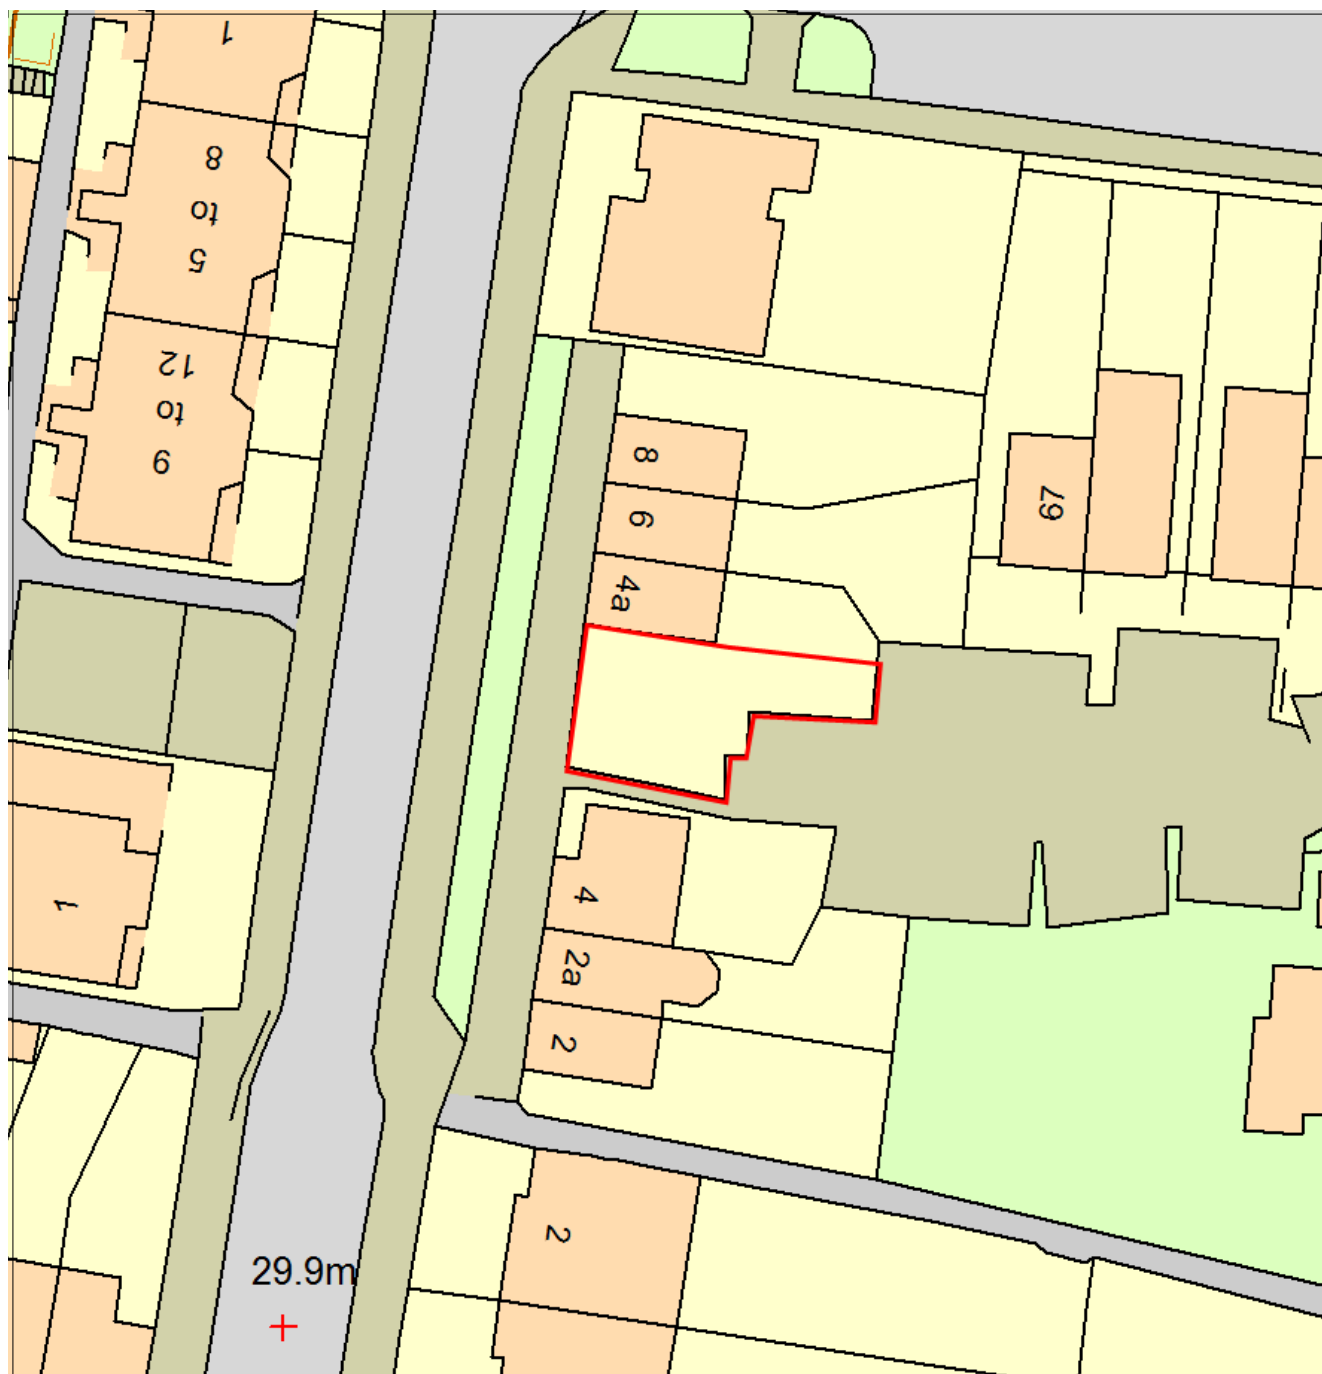
Dwg No: Buckhirst/1220/02

— Approximate Site Boundary

A plan showing the site location is provided as Figure 1, the current site layout is detailed on Figure 2 and an aerial photograph is included as Figure 3. Selected Site Photographs and Walkover Notes are included as Appendix A. An indicative proposed development plan is included as Appendix B and relevant extracts of a Landmark Envirocheck report are included as Appendix C.

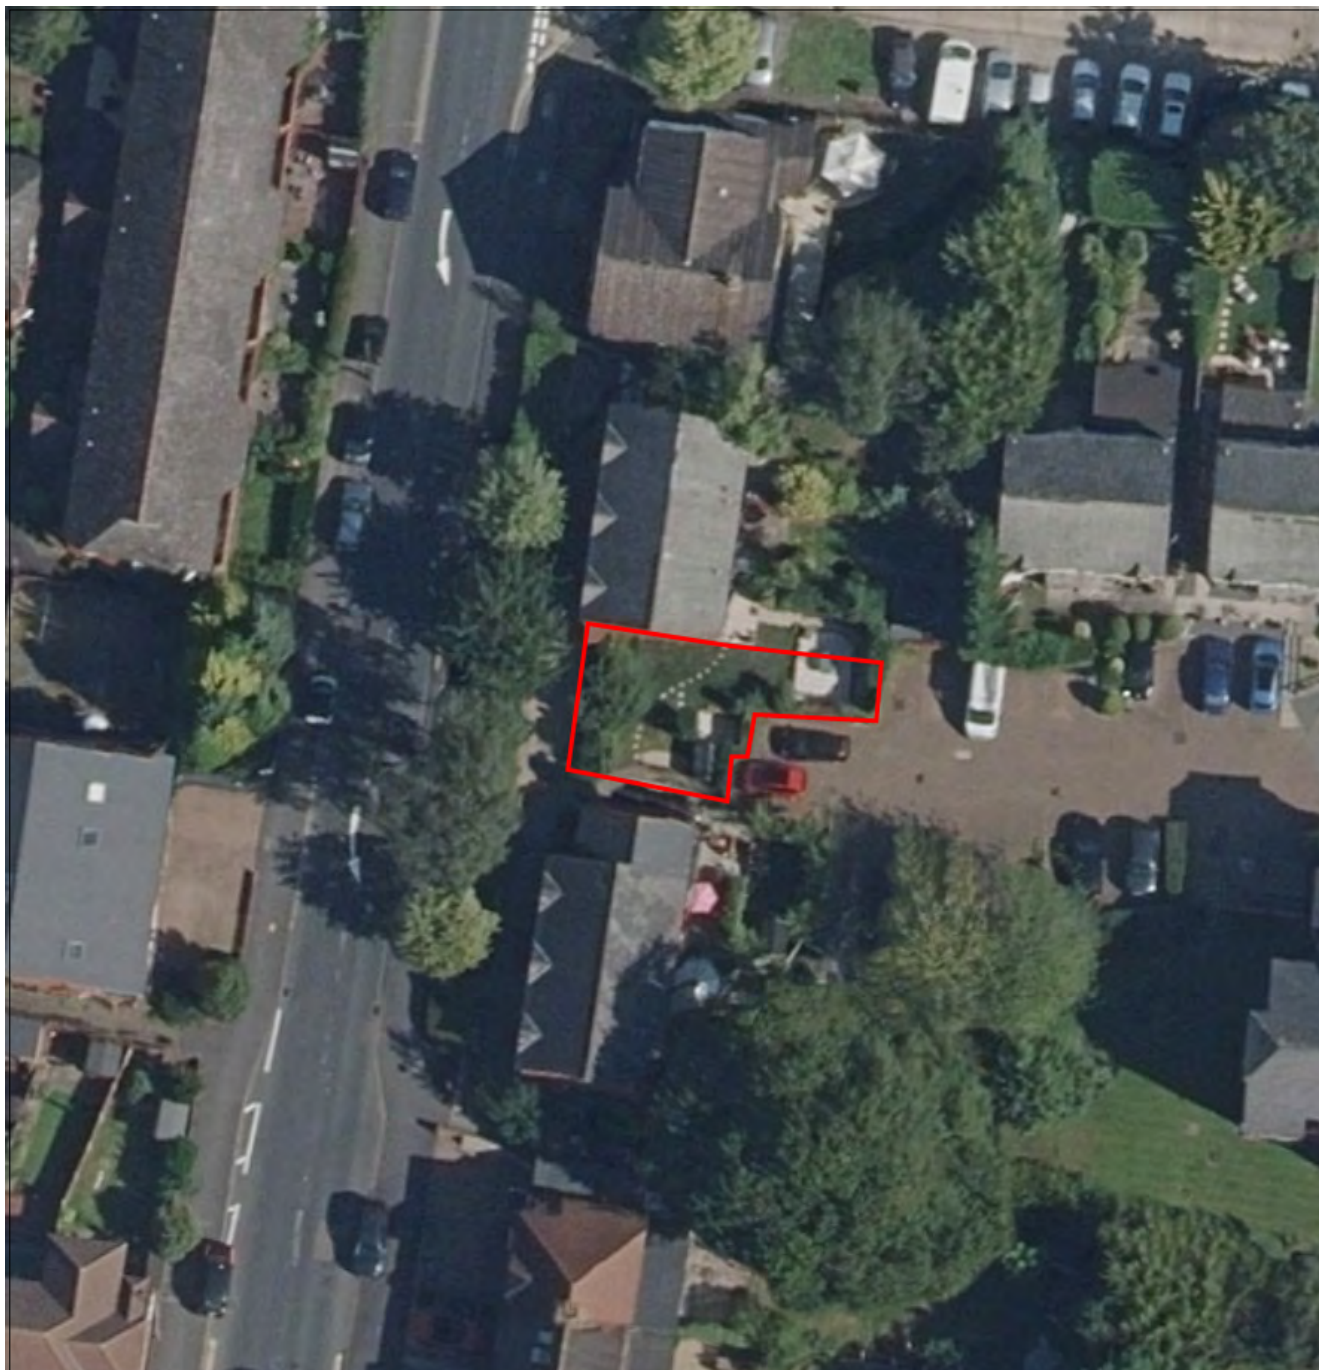
— Approximate Site Boundary
