HERTS & ESSEX SITE INVESTIGATIONS

Phase I DESK TOP STUDY REPORT

***Land at Orchard Way,
Chigwell Row.
IG7 6EE***

***February 2019
Report No. 15249***

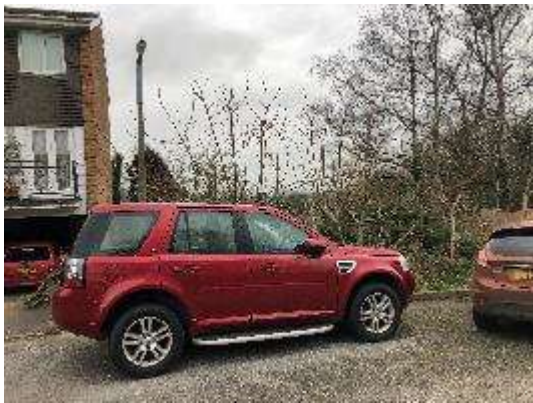
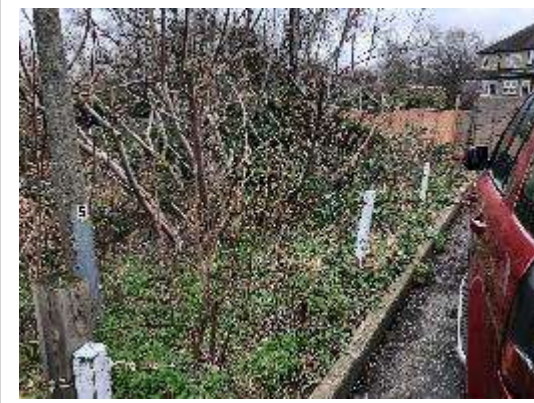
Print 1	View of the front of site area, looking from Orchard Way	Print 2	View within the south of the site area looking to the east

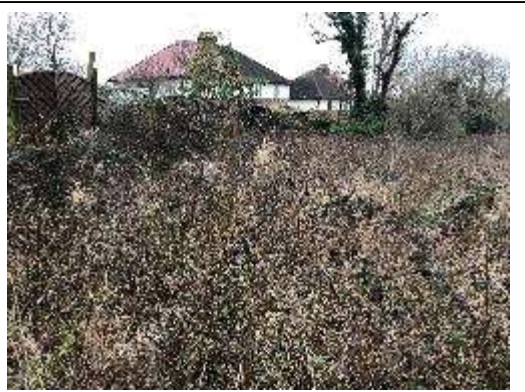
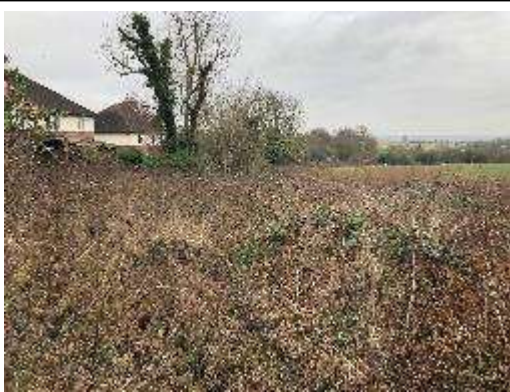
Print 3	View across the southern section of the site area looking to the south	Print 4	View across the southern section of the site area looking to the south west

Print 5	View across the northern section of the site looking to the north west	Print 6	View across the northern section of the site looking to the north

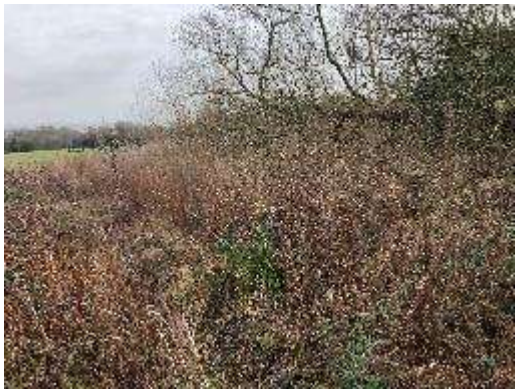
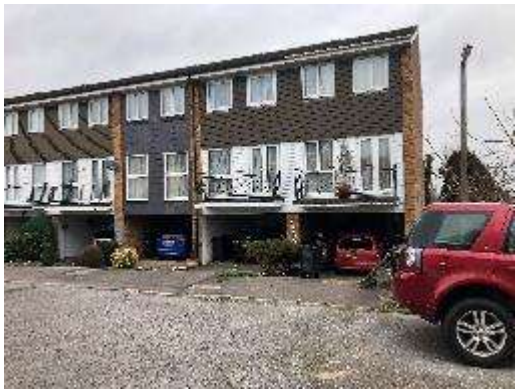
Print 7	View across the northern section of the site looking to the north west	Print 8	View of the dwelling in place off site to the west

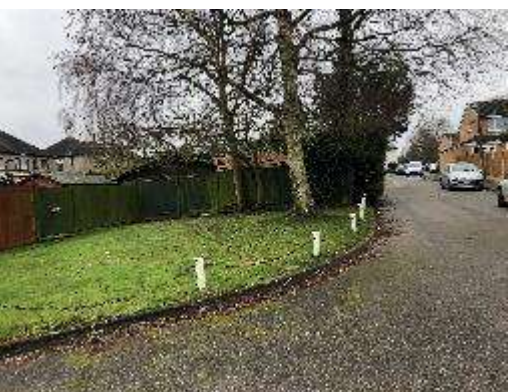
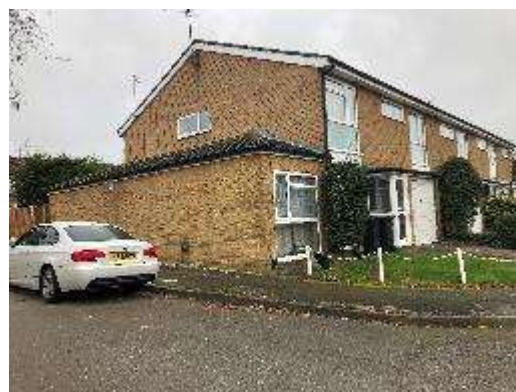
Print 9	View of Orchard Way in place to the south of the site area – looking to the south	Print 10	View of the dwellings in place to the South west of the site area

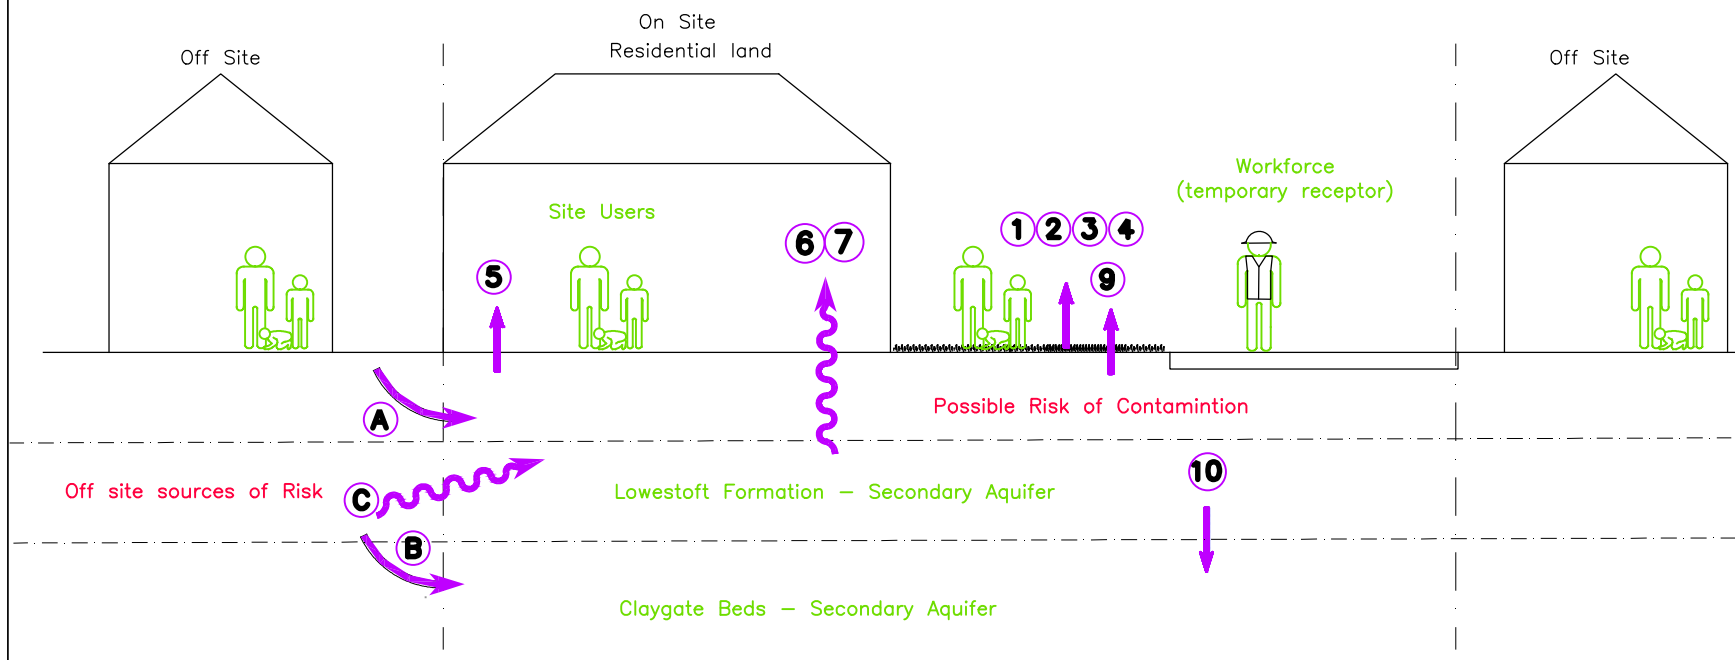
Sketch No: DTS/15249/01/01

- A Migration of contamination to the site area
- B Migration of land gases/ Vapours to the site area
- C Migration of contaminated groundwater to the site area

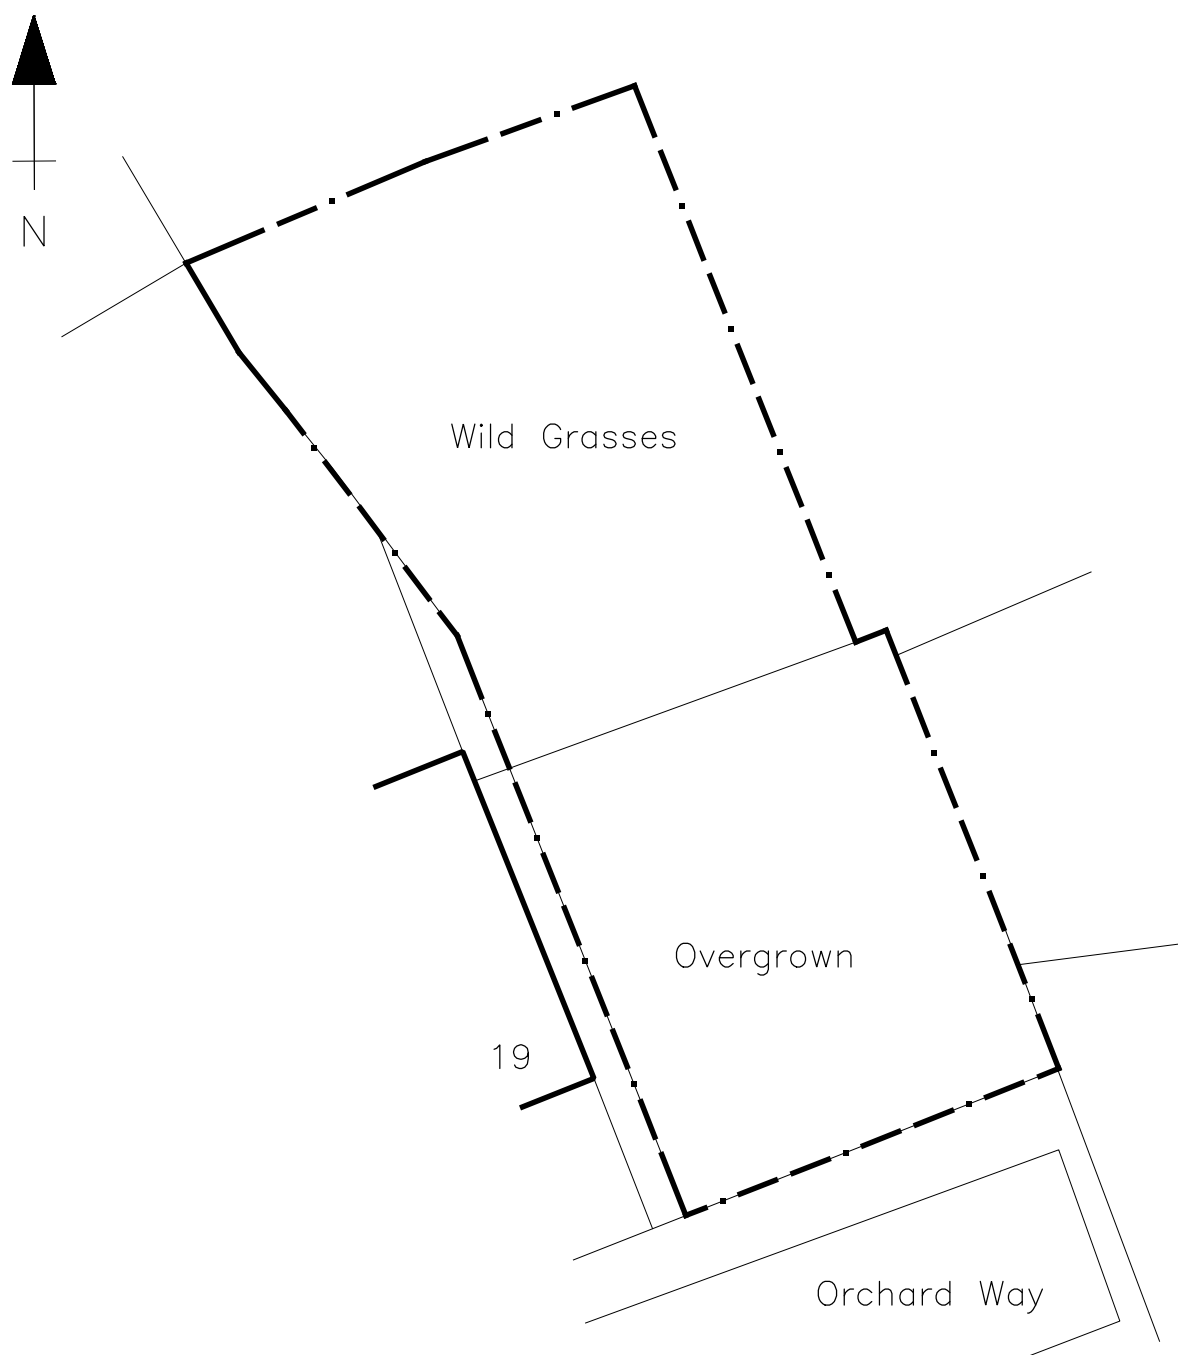
Not To Scale
Sketch No: DTS/15249/02/02

Existing Site Plan
