APPENDIX SEVEN – TREE SURVEY

Arboricultural Impact Assessment

Hill House Farm, Chigwell, Essex.

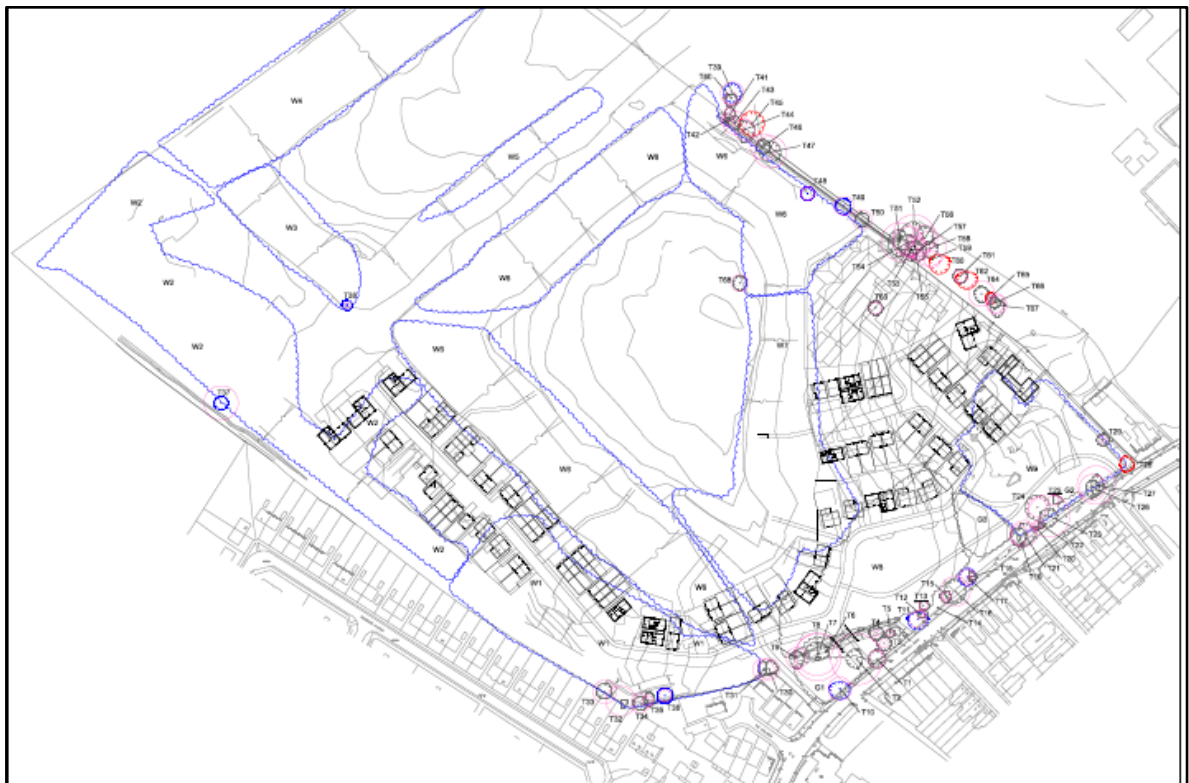
Image 1: Extent of proposed development envelope.

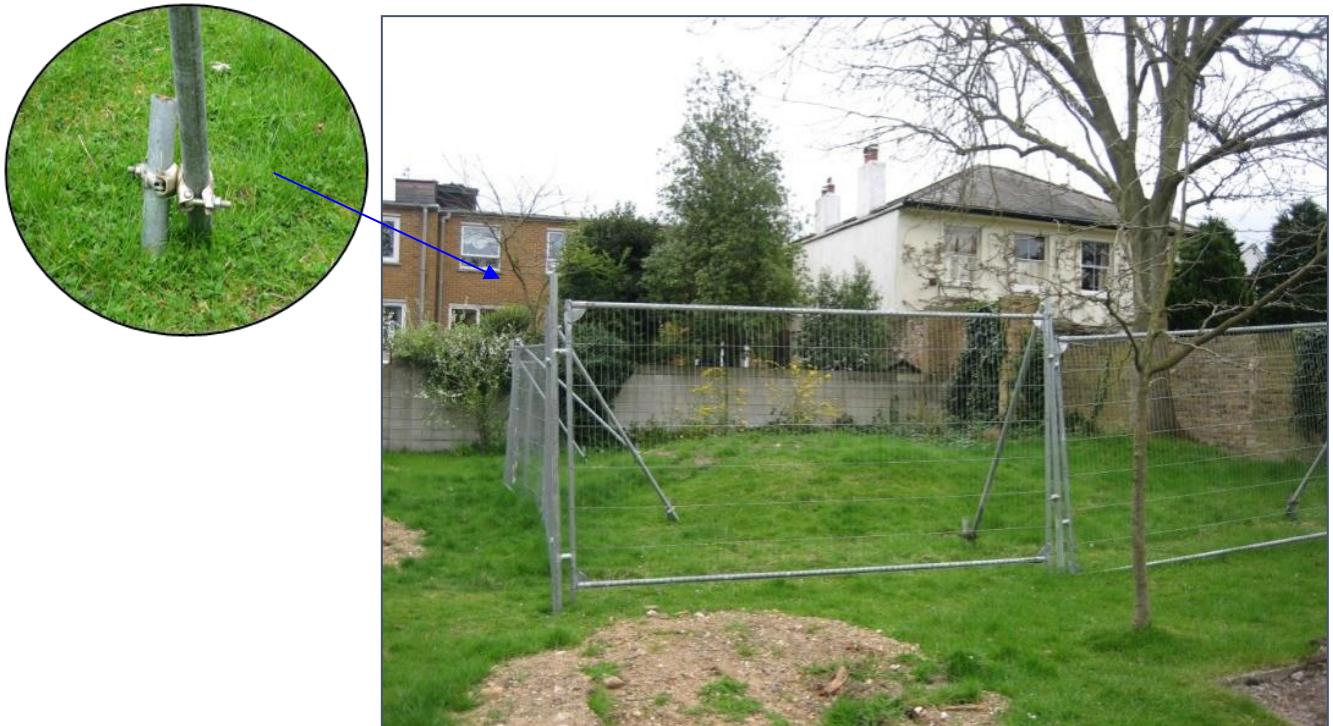
Figure 1 Example of welded mesh barriers in use

- 5.0.2 Where site circumstances and associated risk of damaging incursions into the RPA do not necessitate the default level of protection, an alternative specification may be used if agreed with the local authority. An example would be 'Heras' type welded mesh panels on rubber or concrete feet. The panels should be joined together using a minimum of two anti-tamper couplers, installed so that they can only be removed from inside the fence. The panels should be supported on the inner side by stabiliser struts. See Figure 3 overleaf. All-weather notices should be attached to the barrier with words such as 'TREE PROTECTION ZONE - NO ACCESS'.

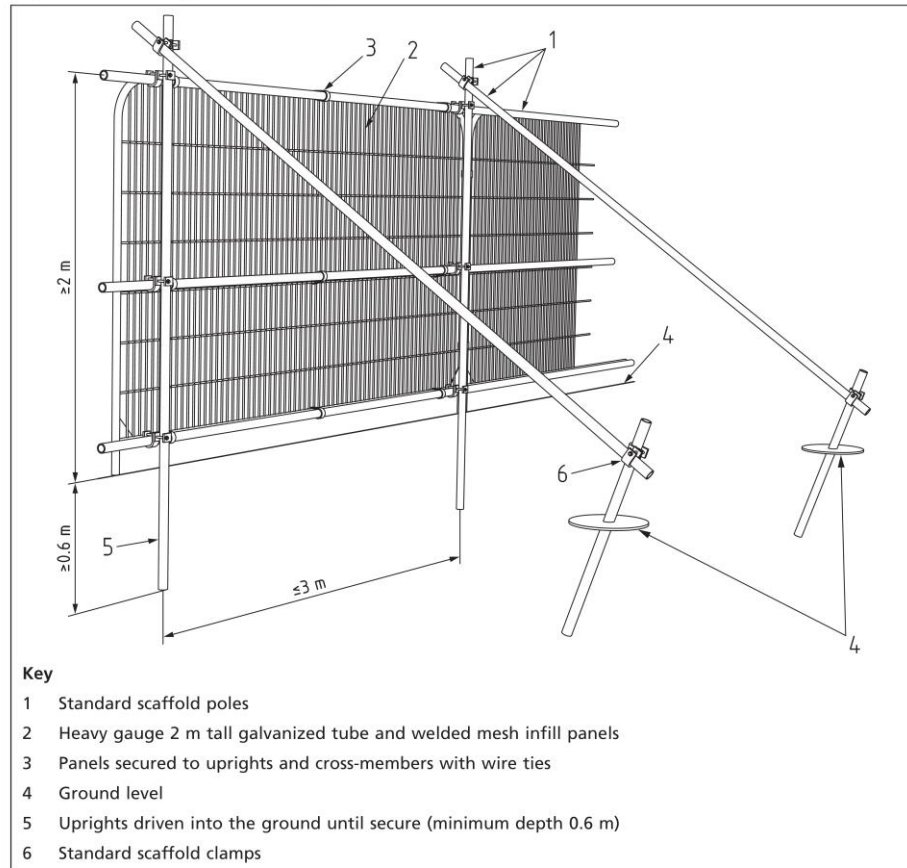
Figure 2 Default specification for protective barrier

- 6.1 The trees identified for retention should be protected during the development phase in accordance with BS 5837:2012 'Trees in Relation to design, demolition and construction – recommendations' (Figure 2) to exclude construction activity within the root protection areas. Barrier fencing, ground protection or a combination of both should be used (see Tree Protection Plan in Appendix 2).

- 5.0.1 **Specifications:** Barrier shall be a minimum 2 m high. It shall consist of a vertical and horizontal scaffold framework, well braced to resist impacts, as illustrated below. The vertical tubes should be spaced at a minimum interval of 3 m and driven securely into the ground. Onto this framework, welded mesh panels should be securely fixed. See Figure 2 overleaf.

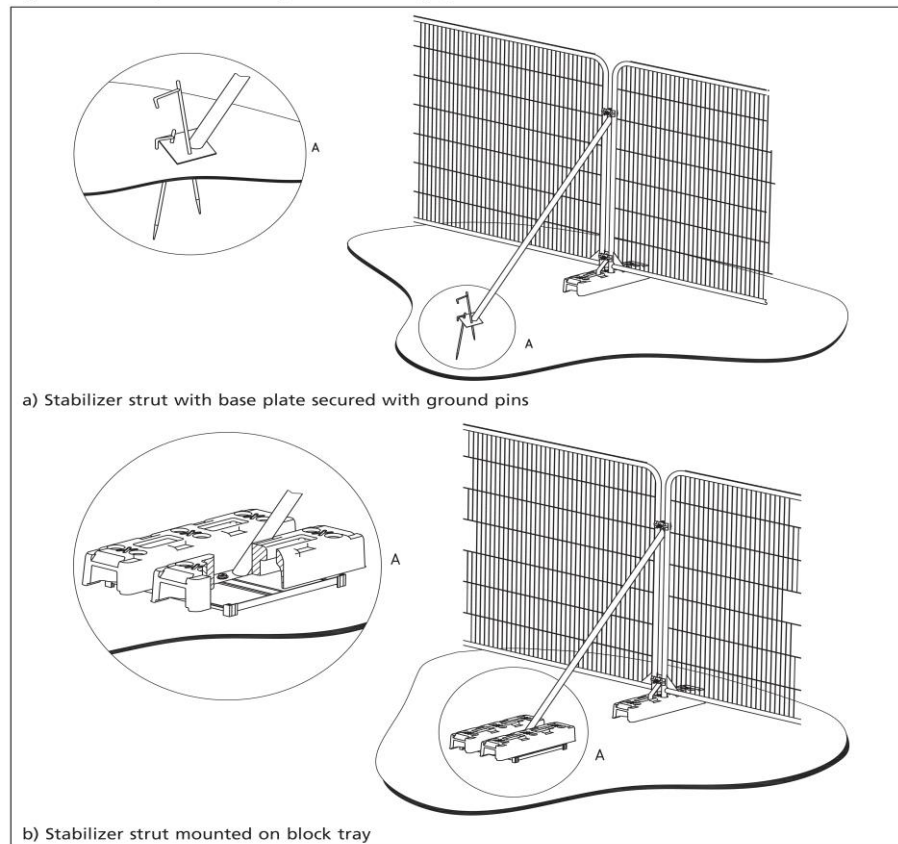
Figure 3 Examples of above-ground stabilizing systems

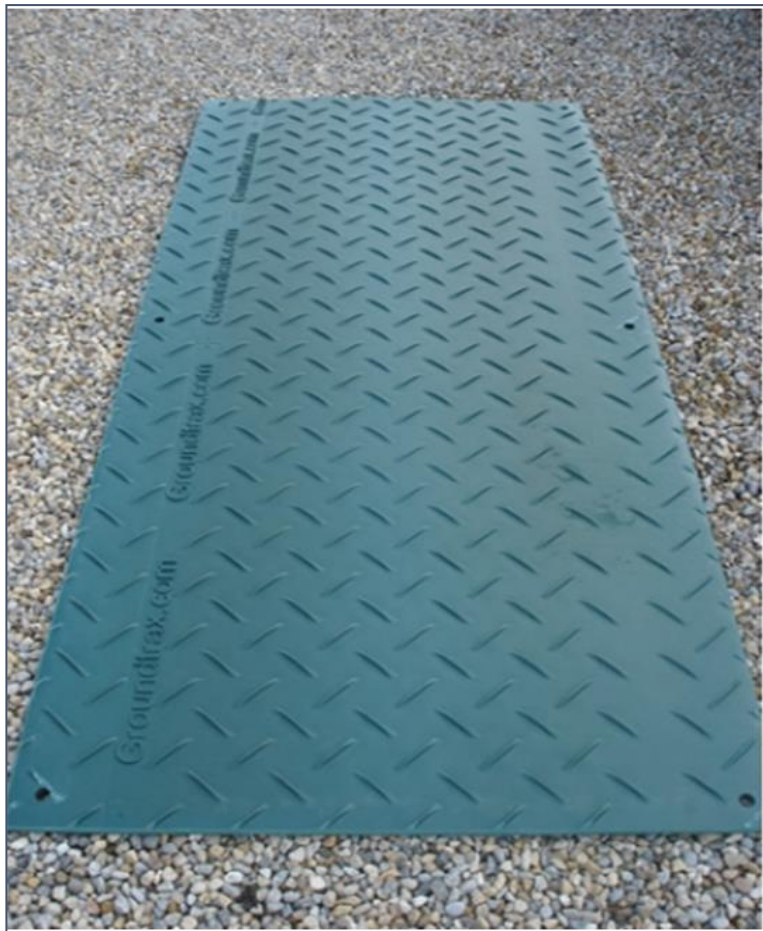
5.1.3 Example of proprietary ground protection panels

5.1.2 The following is a list of suppliers of temporary ground protection including polymer, metal or wooden panels. Other companies supply similar products and the following are given only as an example:

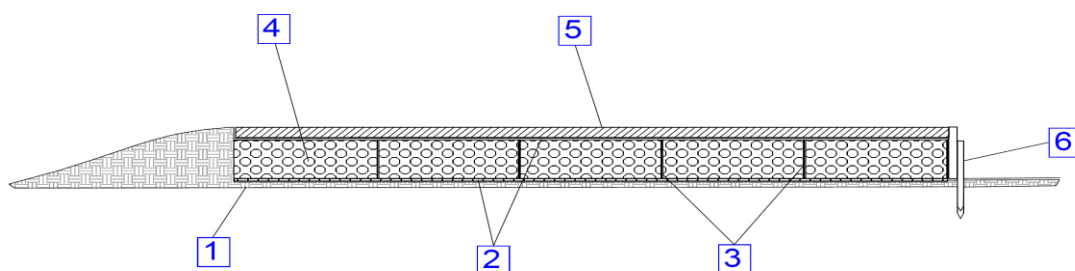
- 1** Existing ground
- 2** Geotextile membrane
- 3** Cellular confinement system

- 4** 20/40mm clean angular stone
- 5** Porous surface layer
- 6** Timber retaining edge

- *no excavation other than the removal of existing hard surfaces if required, or the removal of surface vegetation and no more than 50mm of leaf litter, vegetation debris etc;*
- *a method to spread and support the load of the hard surface and anticipated usage without causing compaction of the soil structure beneath;*
- *the use of a porous sub-base and finishing layer to allow water and air diffusion in and out of the soil;*
- *porosity must be designed to be long-term and not to block with fine particles in the short-term; therefore, irregular, no-fines aggregate must be used; and*
- *the pH of the aggregate must be considered as many conventional road stones have very high pH values which can damage susceptible trees and therefore aggregates with a near neutral pH should be preferred.*

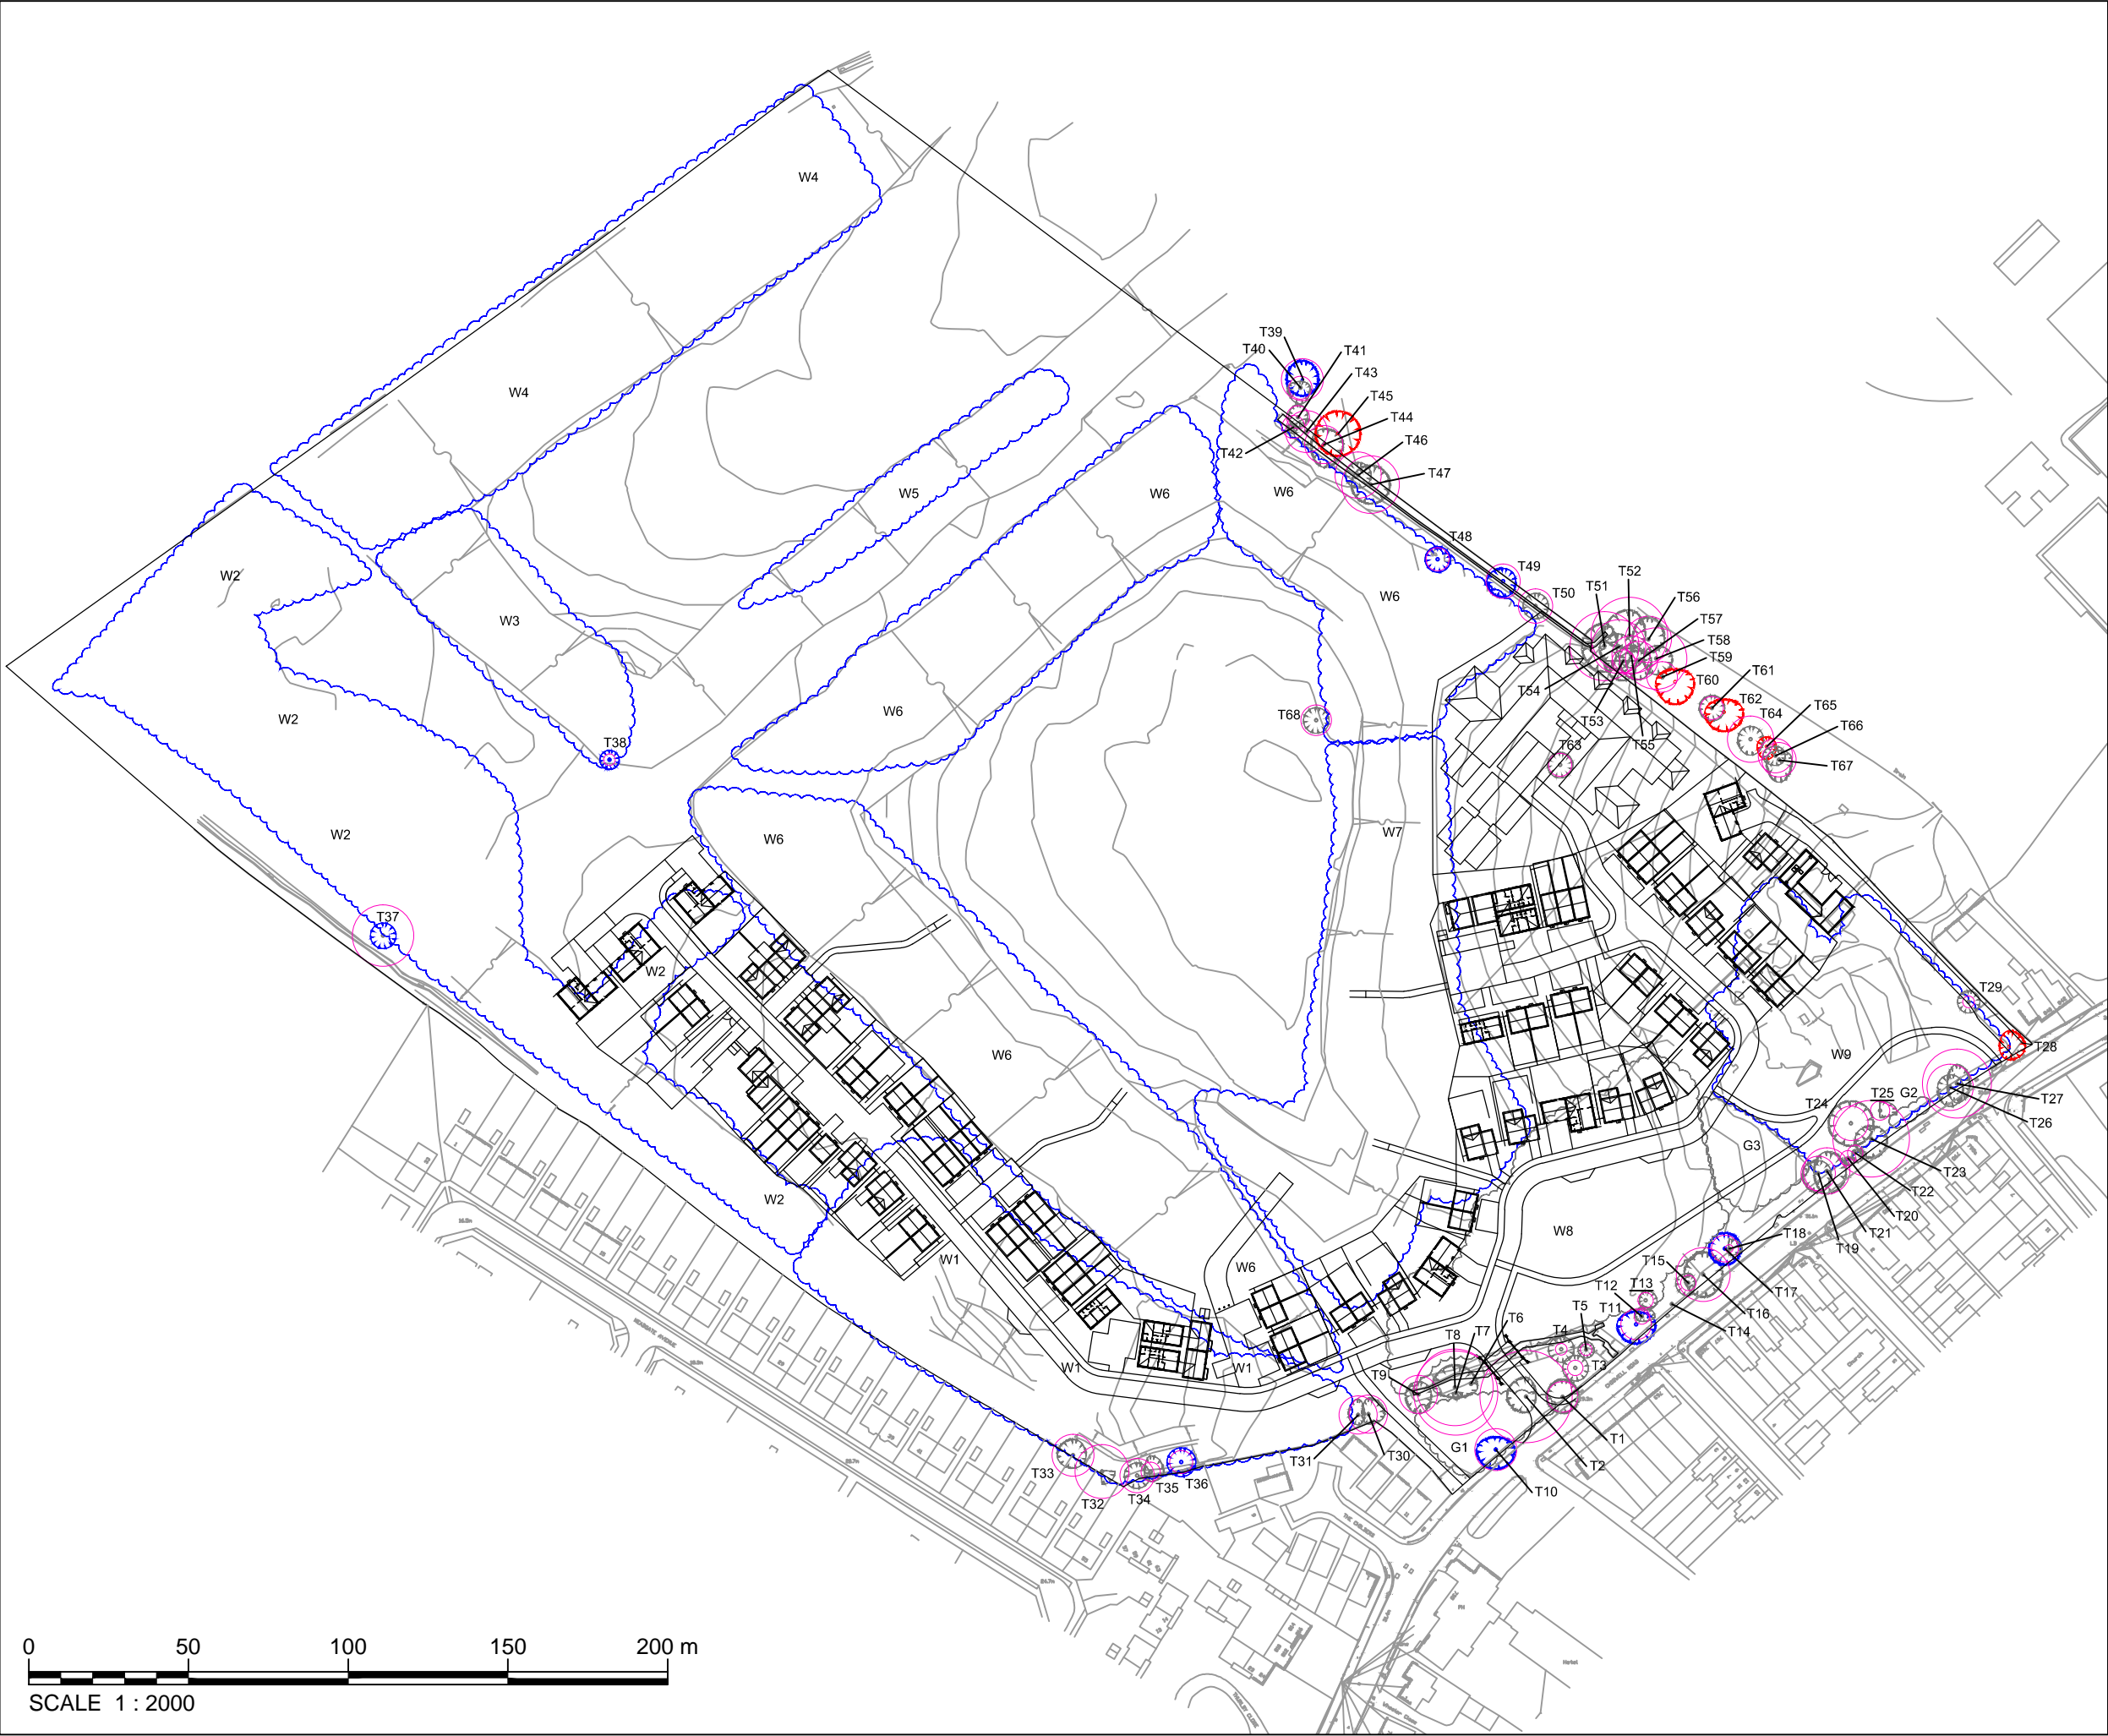
Key

Category A - trees of high quality and value

The plan found at appendix 4 shows the existing trees numbered and categorised in accordance with BS 5837. Below ground constraints are represented by the RPA. The above ground constraints are represented by the trees crown spread and height where appropriate. The survey plan is an aid to design and should not be used post consent on site; the tree protection plan is to be used for this purpose.
