North Weald Golf Course
Viewpoint Location Plan

Viewpoints 1 - 3

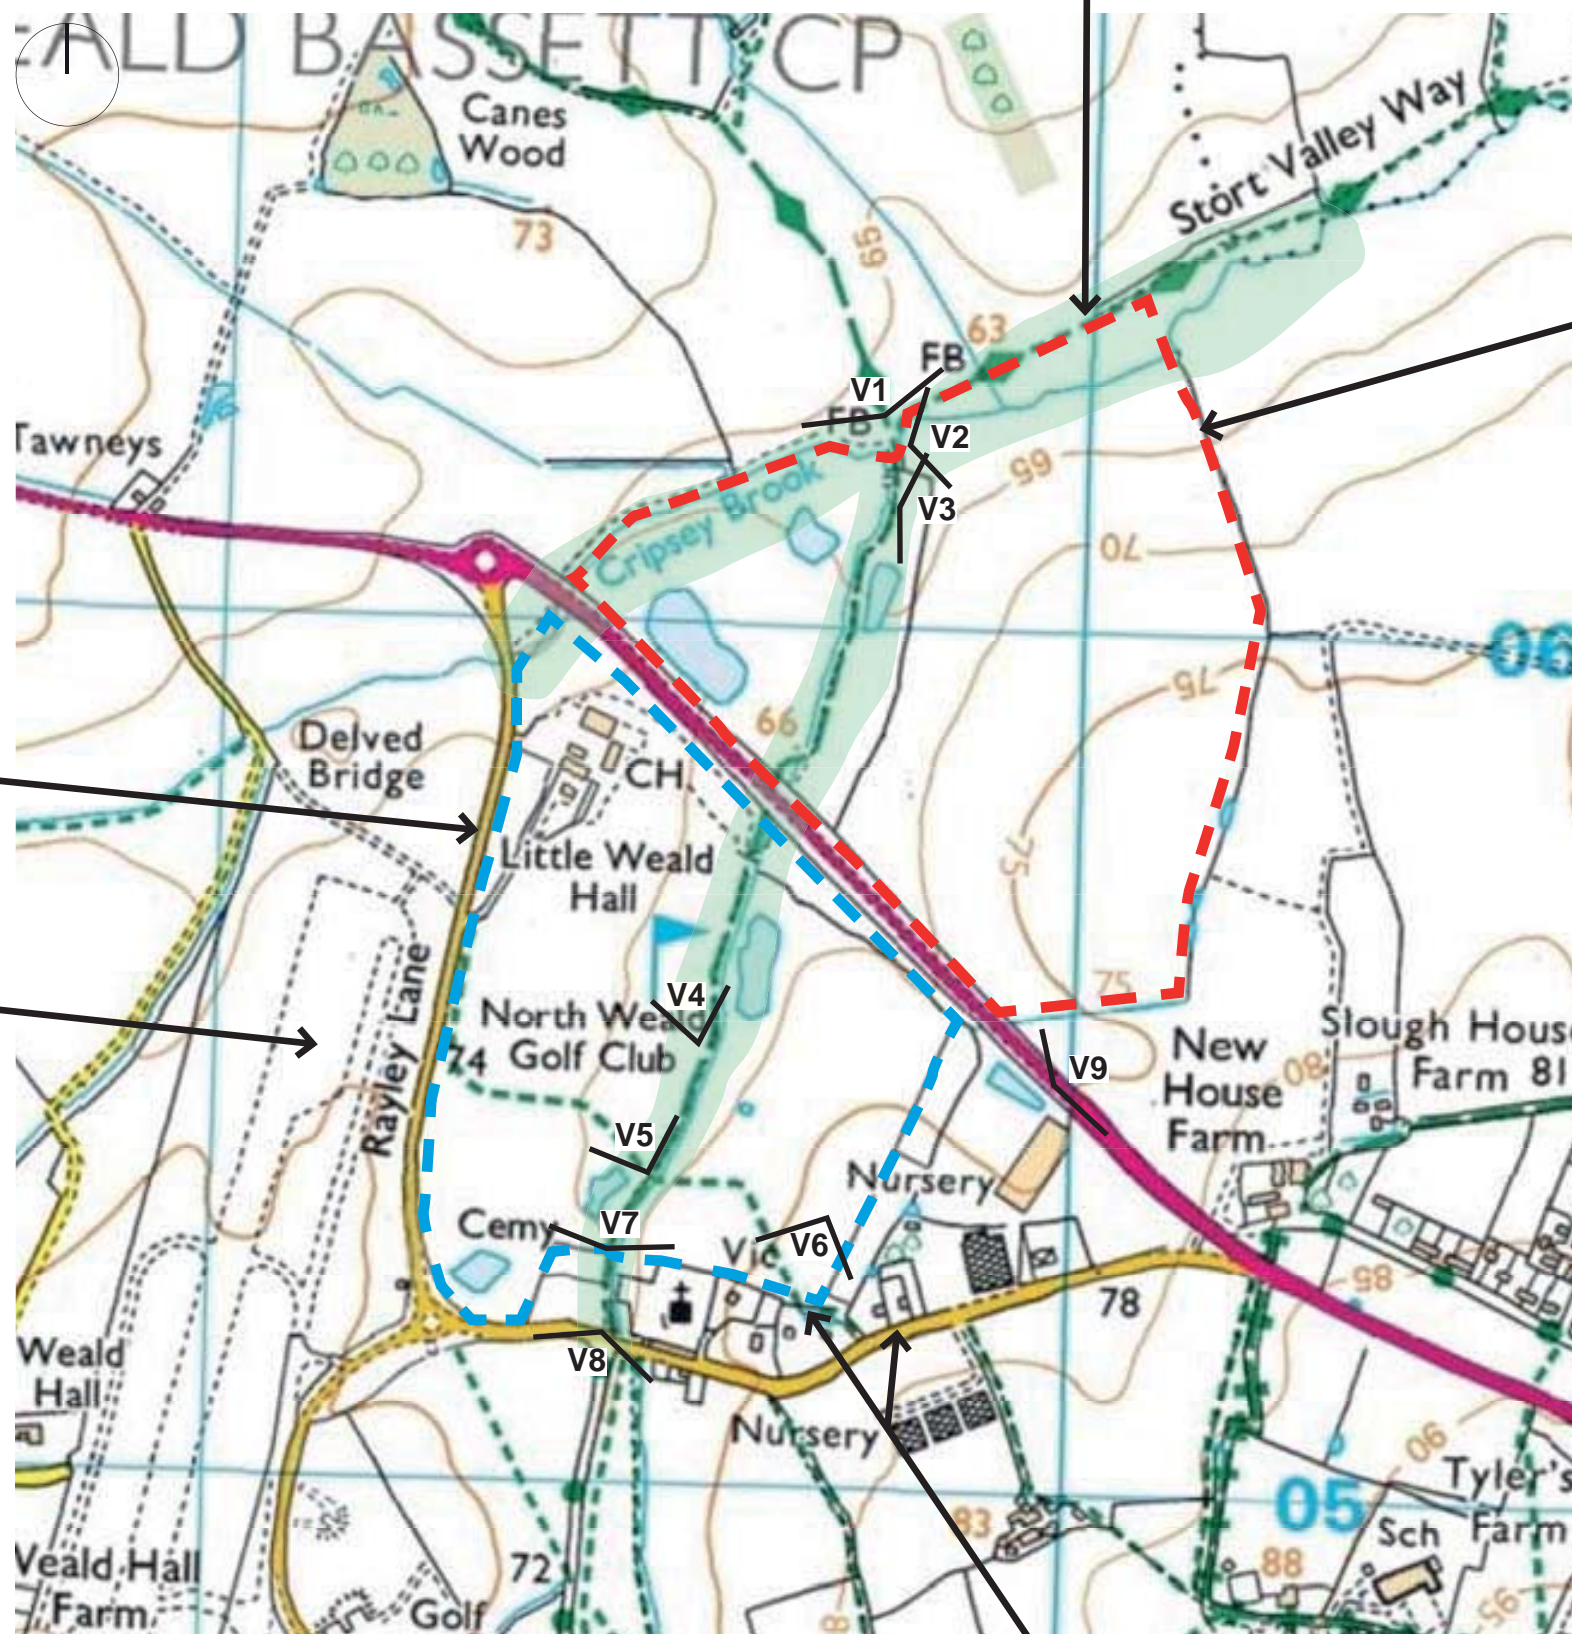
Cripsey Brook & riparian
vegetation provides moderately
strong boundary

Established
hedgerow provides
moderately strong
boundary

Rayley Lane bounded by
substantial
hedgerows provides
significant boundary

Vicarage Lane along with built form and
substantial hedgerows provides significant
boundary

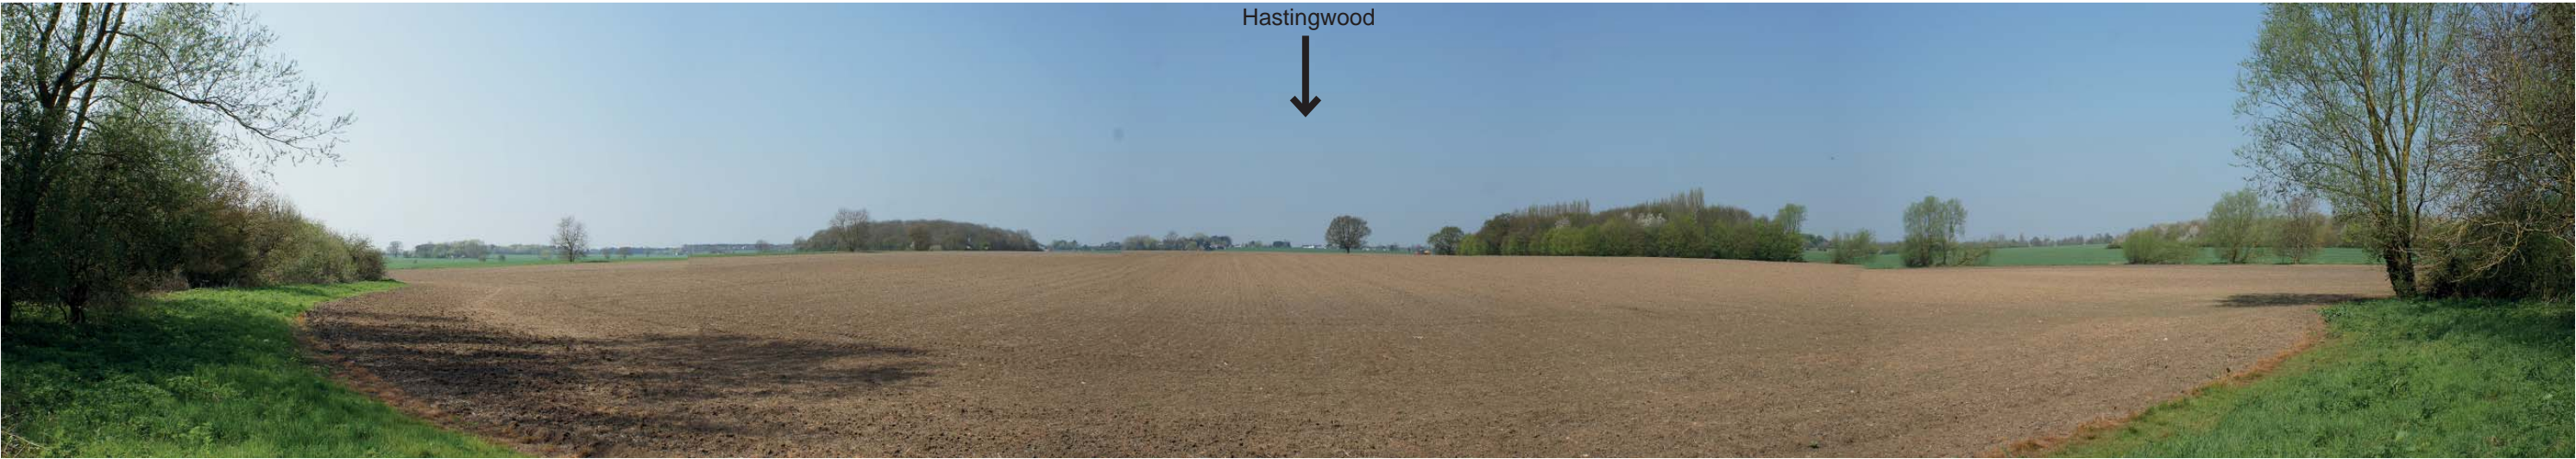
View 1
180 degree view to the north of Cripsey Brook, just outside of the parcel to the north of the A414, showing open countryside to the north

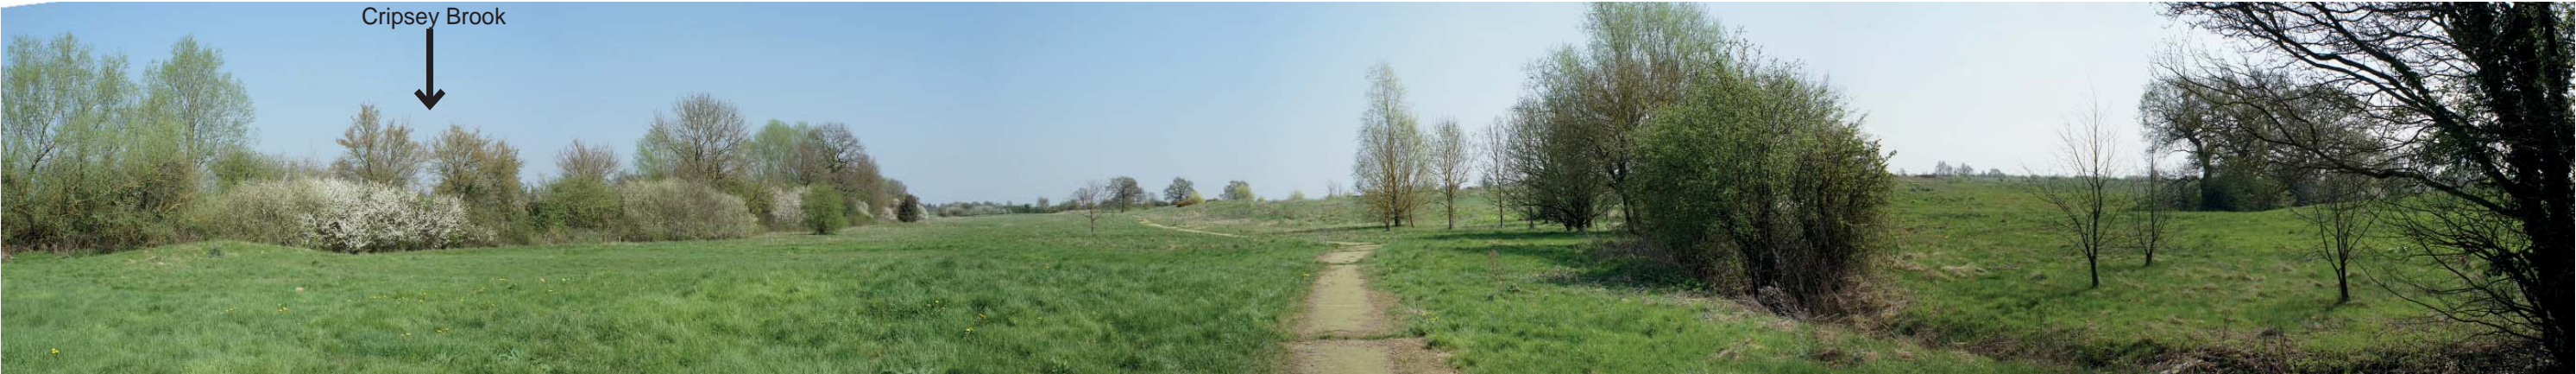
View 2
180 degree view to the east from within the parcel to the north of the A414, showing the moderately strong boundary of the Cripsey Brook & associated riparian vegetation

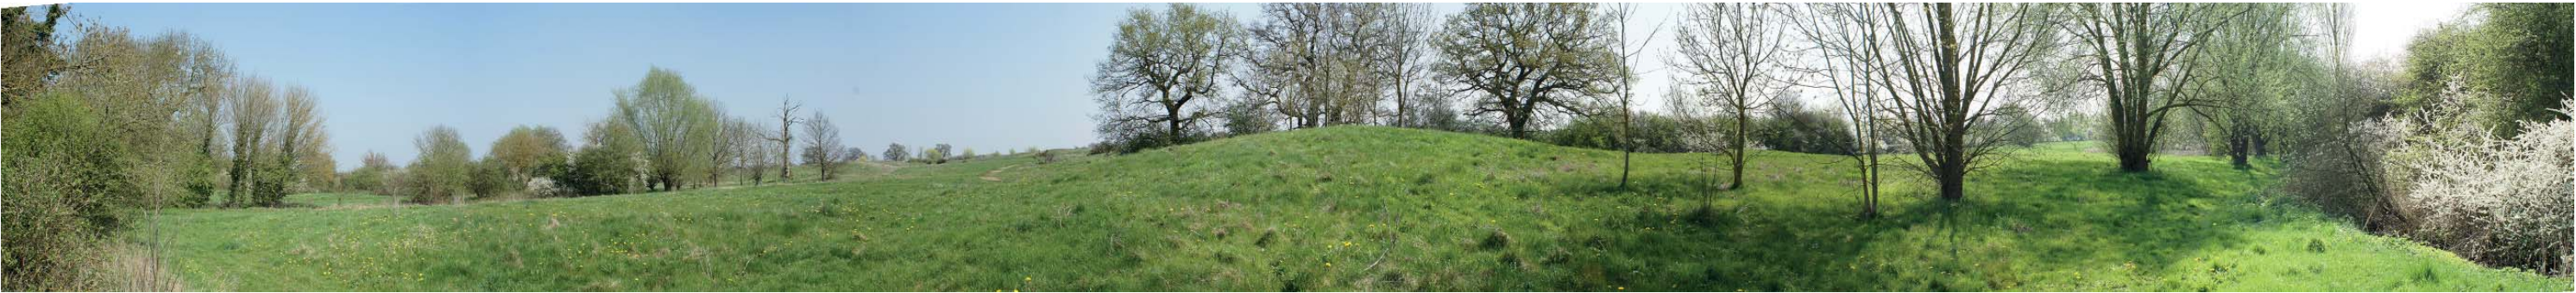
View 3
180 degree view to the east from within the parcel to the north of the A414, showing how the undulating landform provides screening for the rest of the site

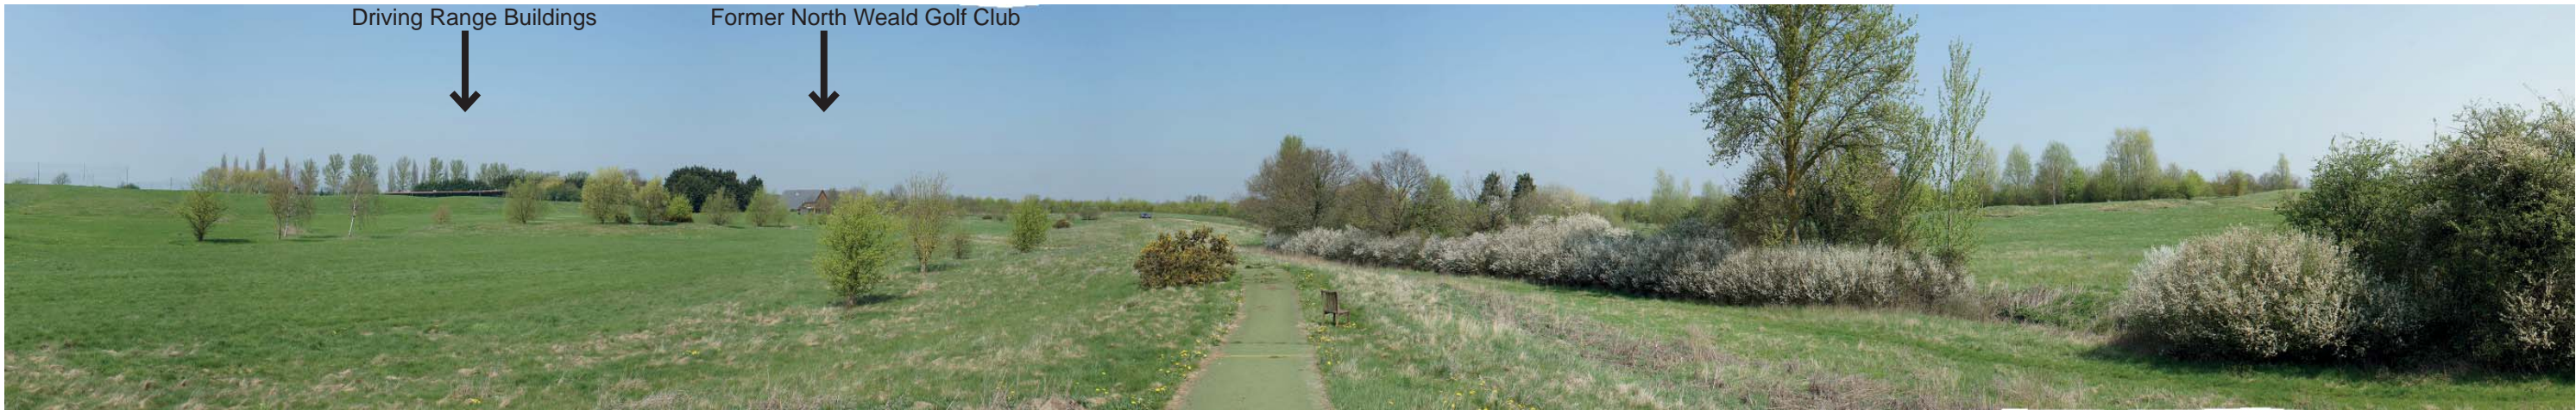
View 4
90 degree view to the north from within the land to the south of the A414, showing stream with potential for enhancement as an ecological corridor & bridleway running through the site

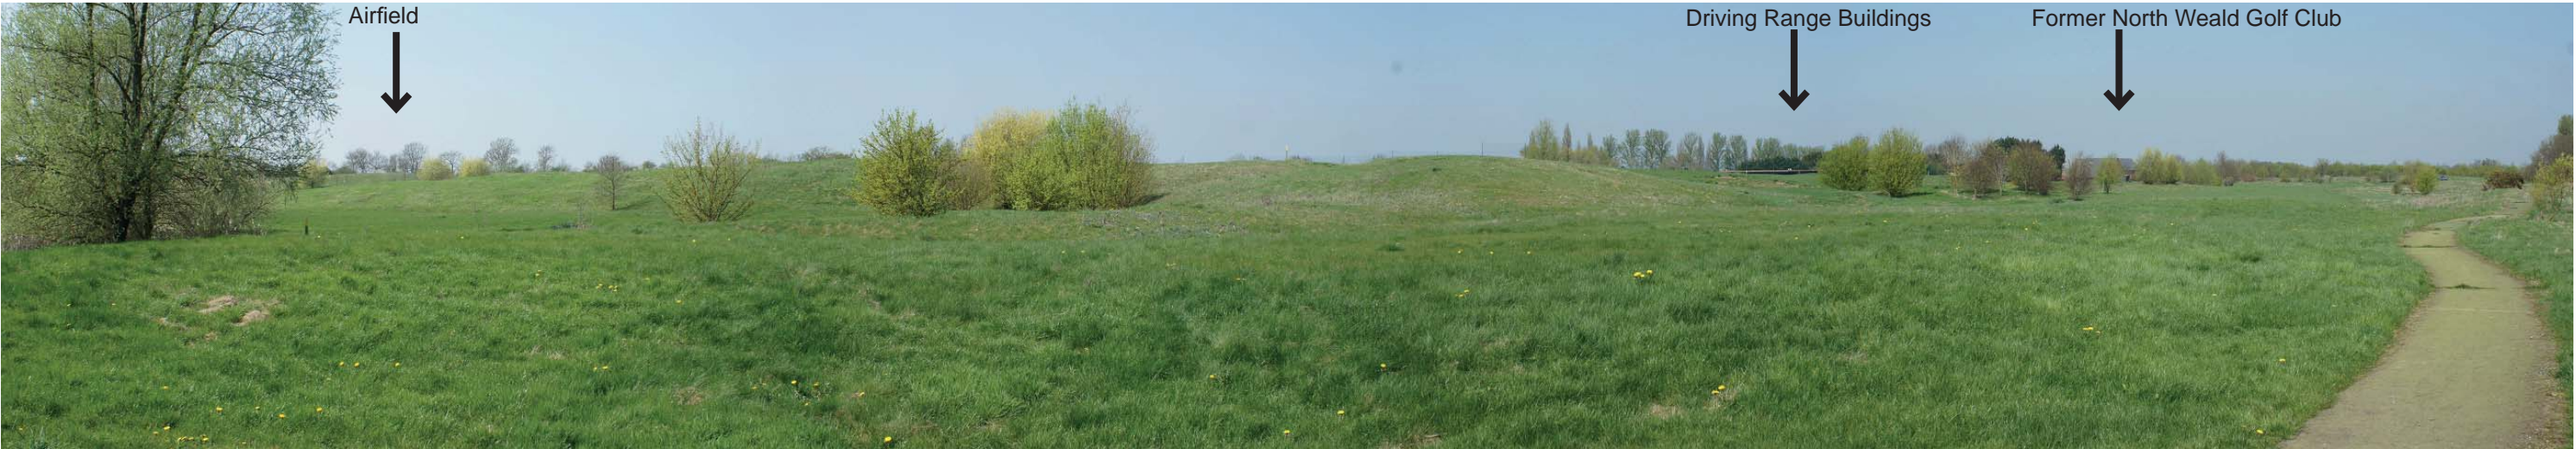
View 5
90 degree view to the north west from within the land to the south of the A414, showing the enclosed nature of the landscape within the parcel boundary

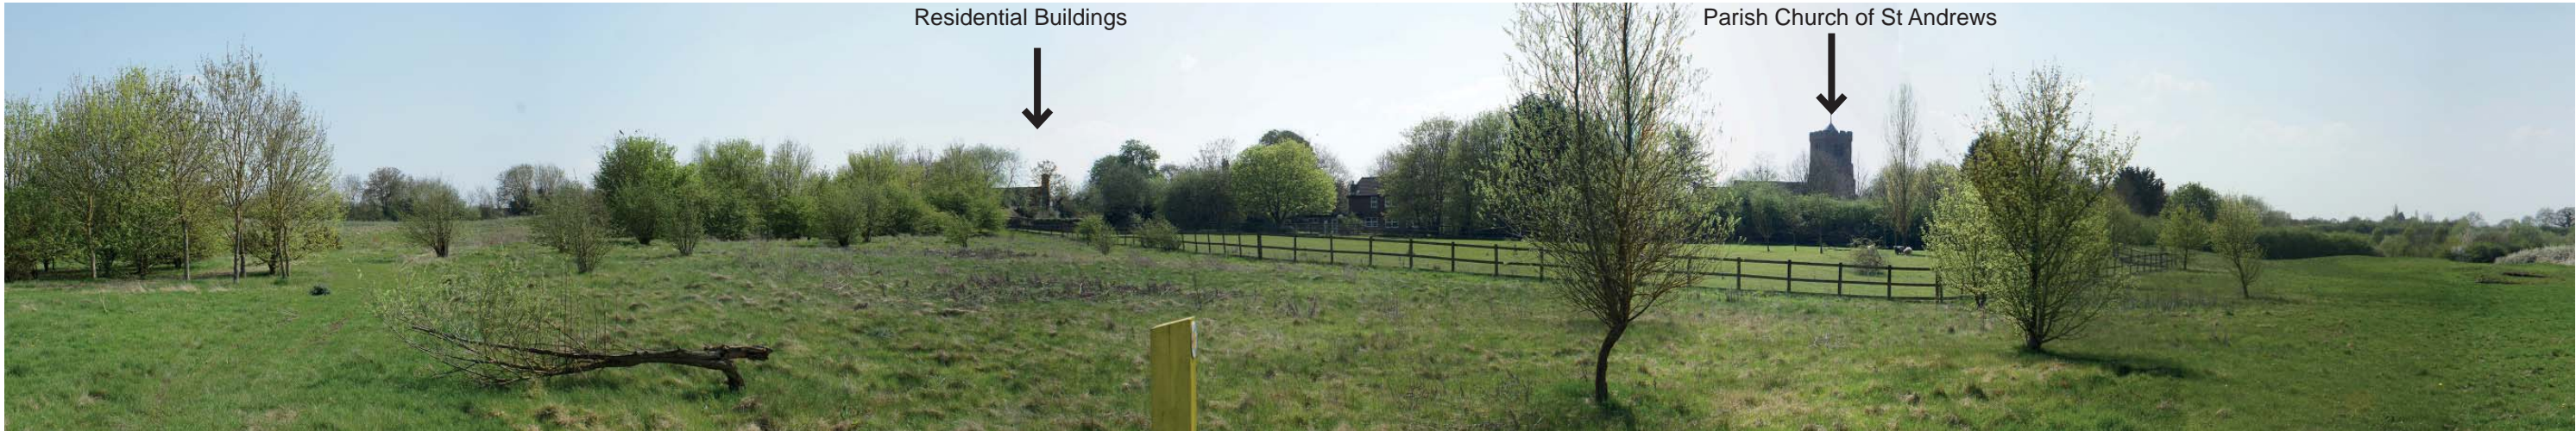
View 6
From within the land to the south of the A414, towards Vicarage Lane showing the strong boundary of the built form

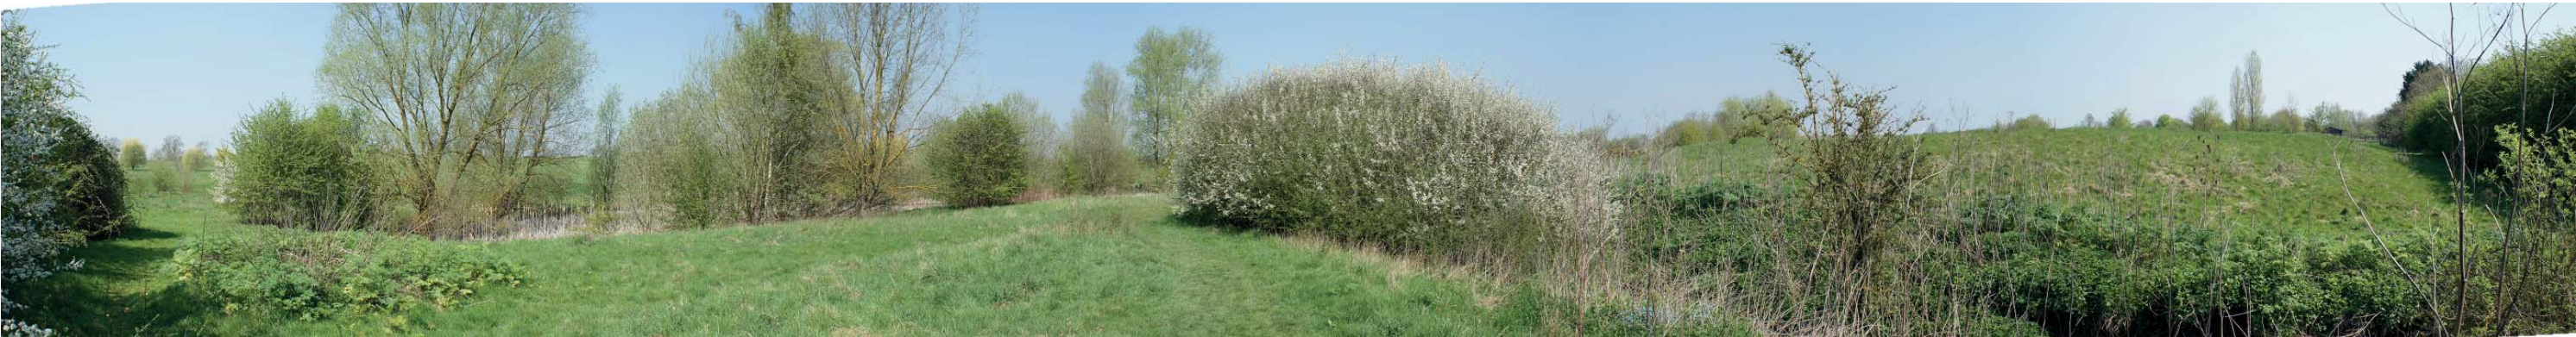
View 7
180 degree view to the north into the parcel to the south of the A414,
showing the enclosed nature of the parcel

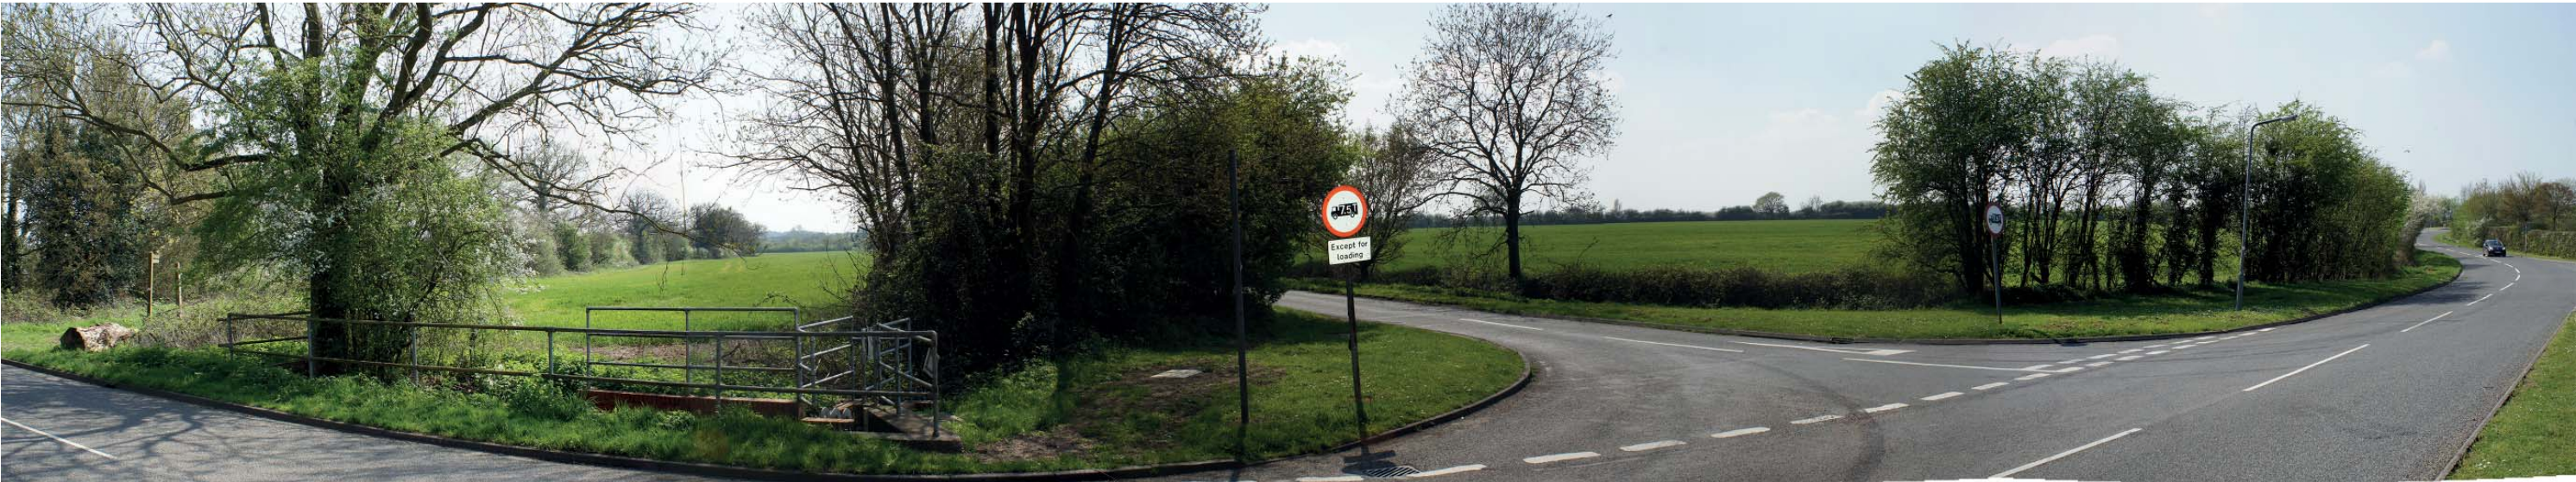
View 8
View south from Vicarage Lane showing the strong boundary created by the road

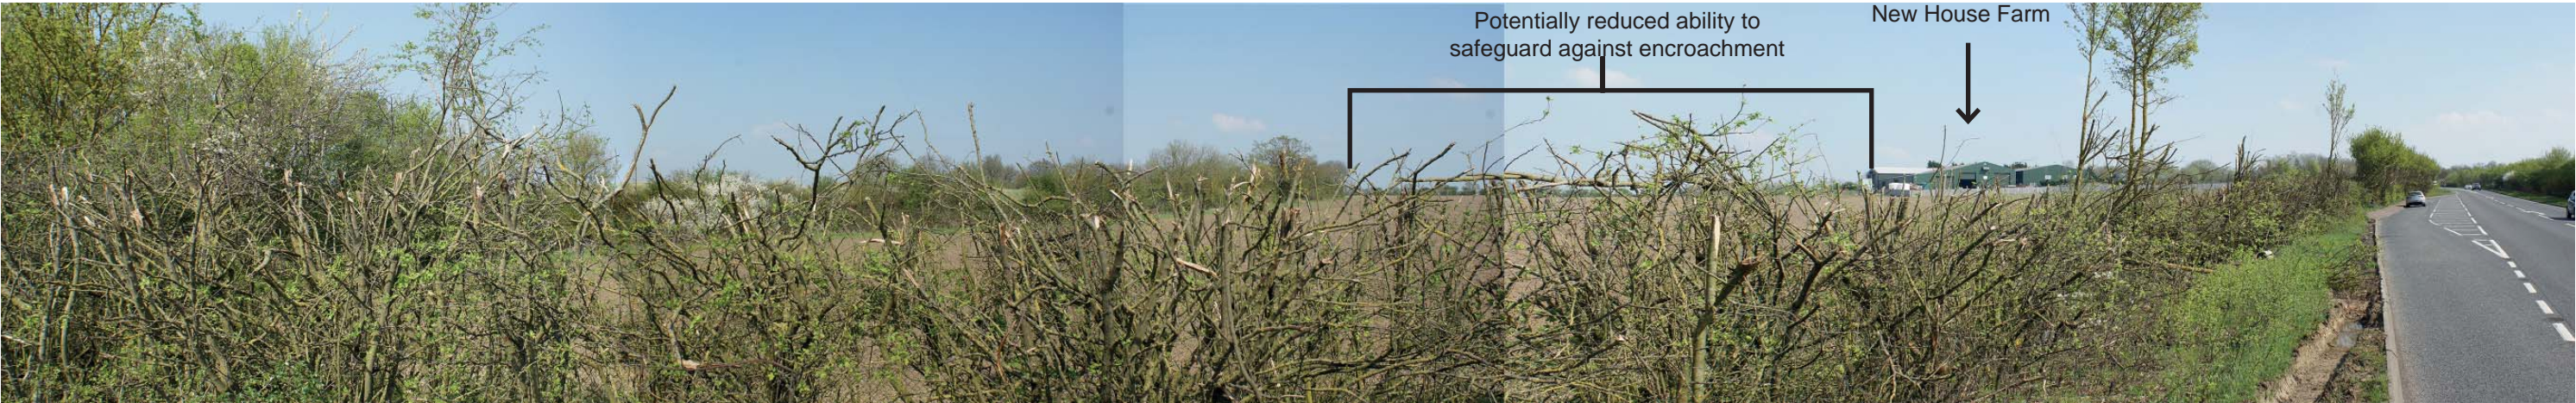
View 9
View towards New House Farm and the eastern boundary of the parcel to the north of the A414, the
countryside would be vulnerable here to further encroachment unless a substantial buffer is provided
