# **FACTUAL REPORT OF INVESTIGATION**

**AT:- Lakeside Nursery, North Street, Nazeing.**

**ON:- 09/12/2016.**

**JOB No:- WP2814**

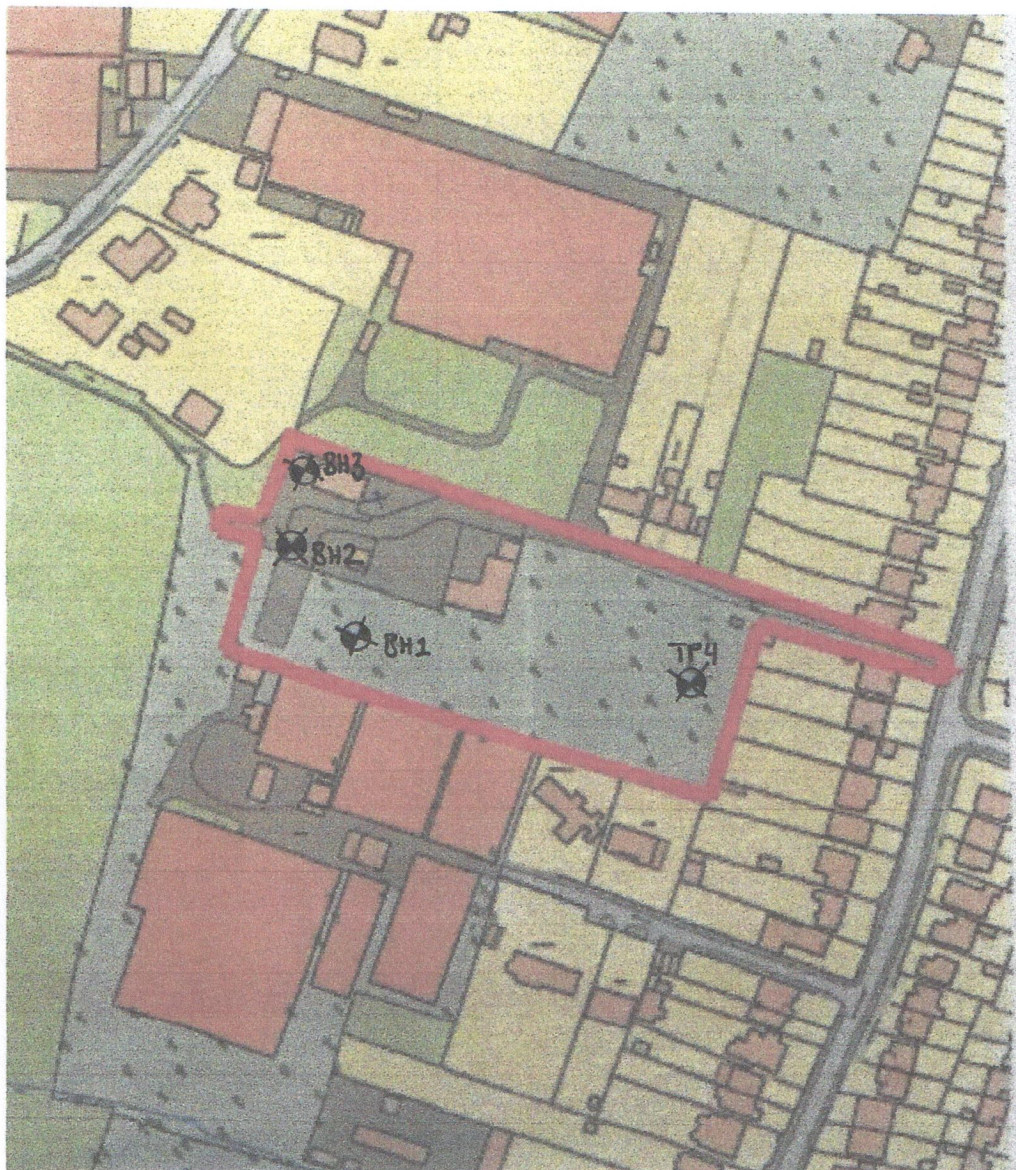
| <b>Site Location Plan</b> | Sheet: 1 of 1 | <br>Tel/Fax 01245 237555 Mobile 07810 820620 |

| Remarks ON SITE TREE IDENTIFICATION<br>FOR GUIDANCE ONLY.<br>NOT AUTHENTICATED. | Key: | Trial Pit<br> MH Man Hole<br> SVP Soil Vent Pipe<br> RWP Rain Water Pipe | Borehole<br> Gully<br> Tree / Bush<br>(approx. ht. in m) |
